Deer Creek Watershed

Ottawa and Muskegon
Counties, MI

Field Surveys
performed by DEQ staff
October 2003

SUMMARY OF DEER CREEK WATERSHED ASSESSMENT OTTAWA, MICHIGAN

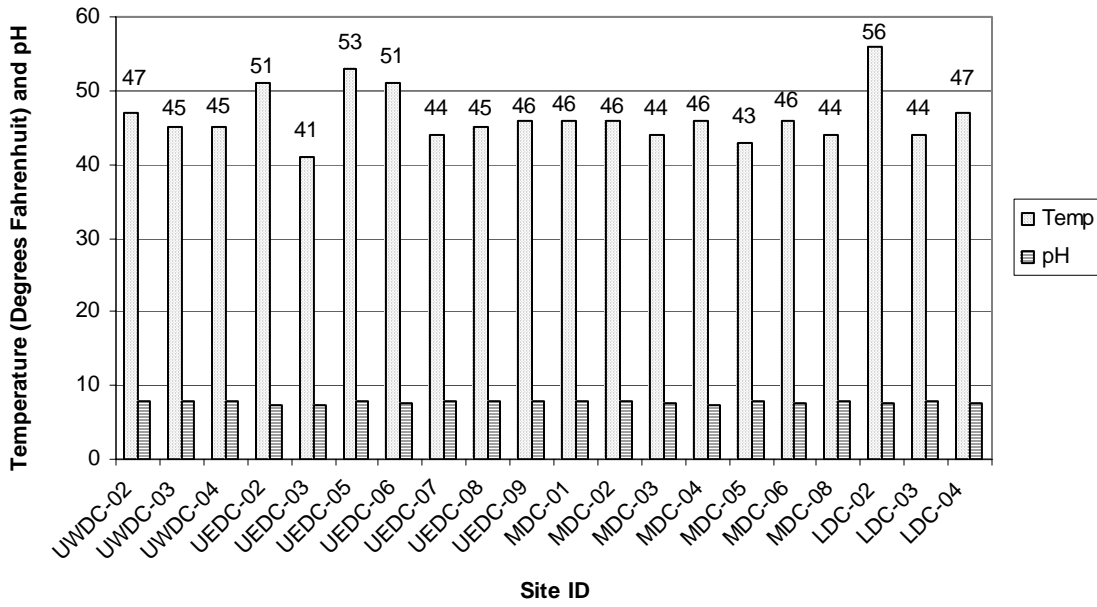
Figure 1. Temperature and pH summary for the Deer Creek Watershed

Survey locations were assessed in the order of upstream sites (in the headwaters) to downstream sites (towards the mouth). Twenty locations, including ten along the main stem of Deer Creek, were measured for temperature and pH. pH values ranged from 7.39 to 7.95, which are not outside of the normal range for streams within Michigan. Overall the average temperature was 46.5° F, with most stations at either 45 or 46° F. One location, at Hayes Road east of 40th Avenue, was 56°F which was the highest recorded temperature within the watershed. This comparatively high reading was due to unknown sources.

Normal stream temperatures capable of supporting a coldwater fishery with few diseases are below 57°F. Walleye, northern pike and some trout are adapted to temperatures between 57° to 68°F, while temperatures over 68°F are suitable for fish communities containing bass, crappie, bluegill, carp and sucker, with occurrence of fish disease high. While temperatures recorded here seem low it is important to note that this survey was not conducted during the hottest summer months when temperature becomes a limiting factor to some species. Temperatures appear cool because the survey was conducted

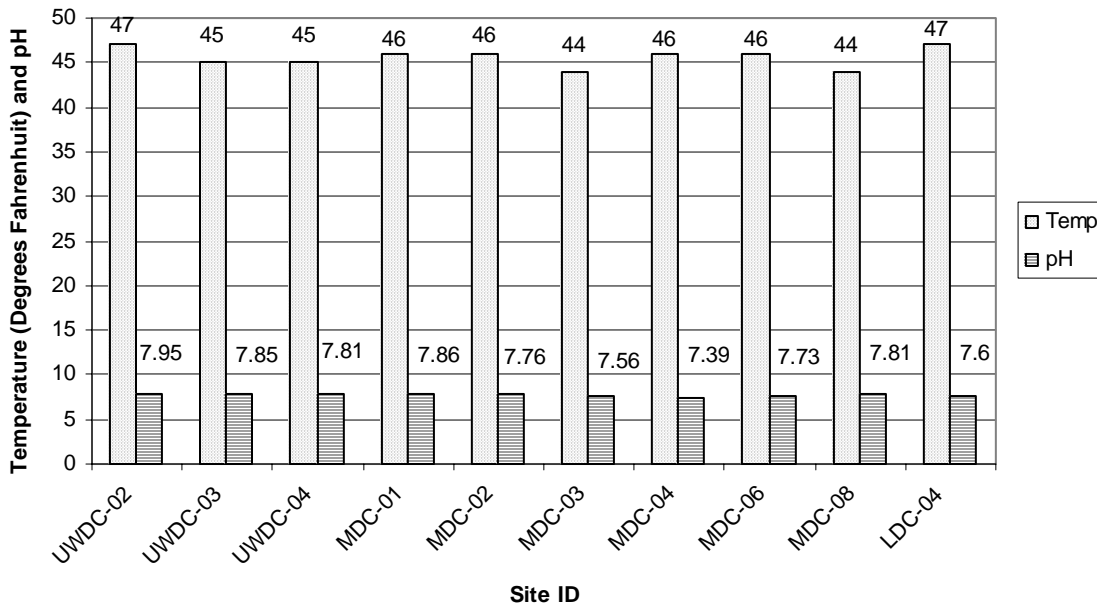
Figure 2. Temperature and pH summary for the mainstem sample locations from the headwaters to the mouth of Deer Creek

during the fall. Maximum air temperatures during the two field days of this survey ranged from 54°F (on October 17) to 57°F (on October 24). Refer to Figure 1 in Attachment B, which depicts the temperature and pH levels at all locations surveyed and to Figure 2, for only those temperatures and pH measurements for the mainstem locations.

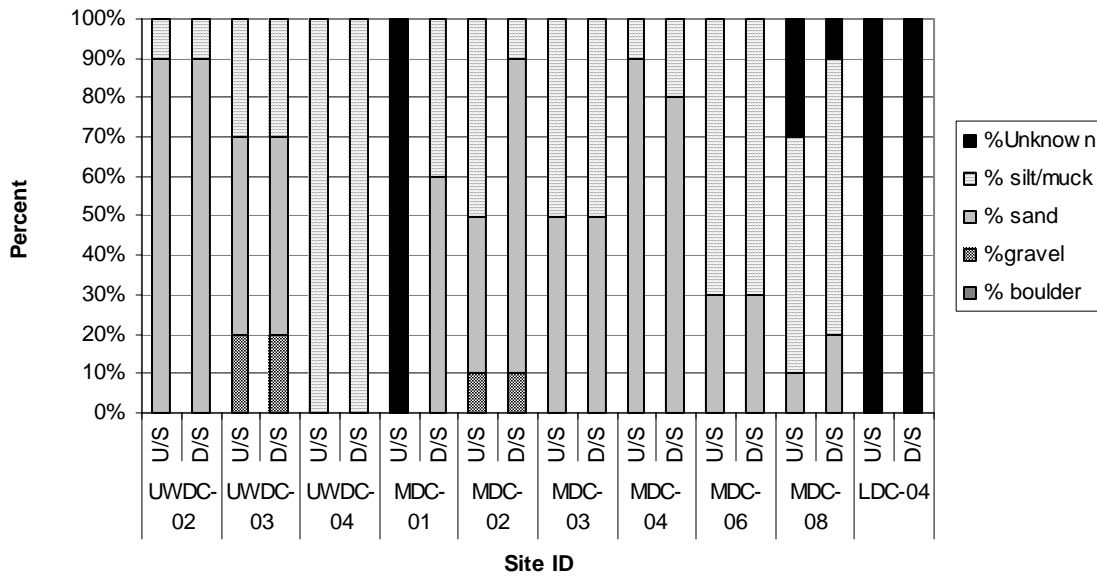
Figure 7. Percent substrate observation for the mainstem sample locations from the headwaters to the mouth

Substrate was observed and quantified for both the upstream and downstream stretch at each survey location. In all, 50 substrate observations were recorded. Substrate type is important when considering habitat suitability for desired species within the system (i.e. trout and other fish species). Cobble and gravel substrates with a low degree of embeddedness are the most suitable for reproduction in many fish species and are important for macroinvertebrates as well. Evidence of silt and sand dominated substrate could indicate problems within the watershed such as erosion and sedimentation. Among the survey locations within the Deer Creek Watershed approximately 26% were dominated (80 to 100% covered by) with sand and 22% dominated by silt, detritus or muck. 20% of the sites were unable to be categorized due to turbidity. None of the sites observed appeared to be dominated by cobble or gravel however 14% of the sites had some amount of gravel present (although it was always less than 20%). Refer to Figures 3 through 6 for substrate data for each of the subwatersheds separately. Refer to Figure 7, in Attachment B, for a graph depicting the substrate composition for those survey locations located along the main channel of Deer Creek.

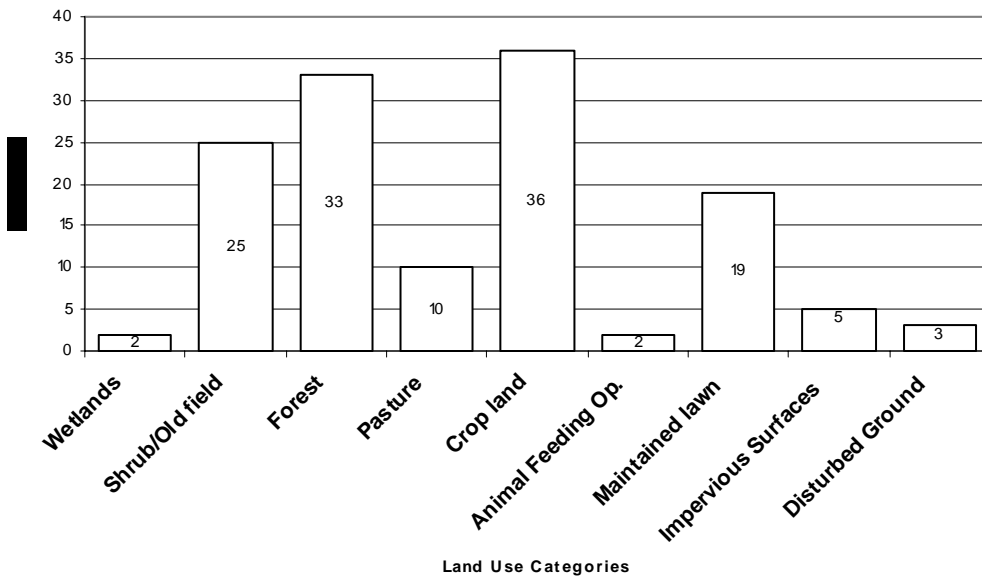
Figure 8. Summary of adjacent land uses

Adjacent land uses were recorded at each survey location for both the upstream and downstream stretches as well as both the right and left banks. Because the entire section of stream that can be seen from the road crossing is evaluated, multiple land uses can be recorded for each site. Land uses within the watershed play an important role in nutrient input, erosion, and in-stream conditions that affect water quality, quantity and habitat. Refer to Attachment B, Table 4 and Figure 8 for a summary of all the adjacent land uses recorded within the watershed. The most common adjacent land uses were crop land, forest and shrub/old field followed by a lesser number of observations for pasture, impervious surfaces, maintained lawns, disturbed ground and wetlands.

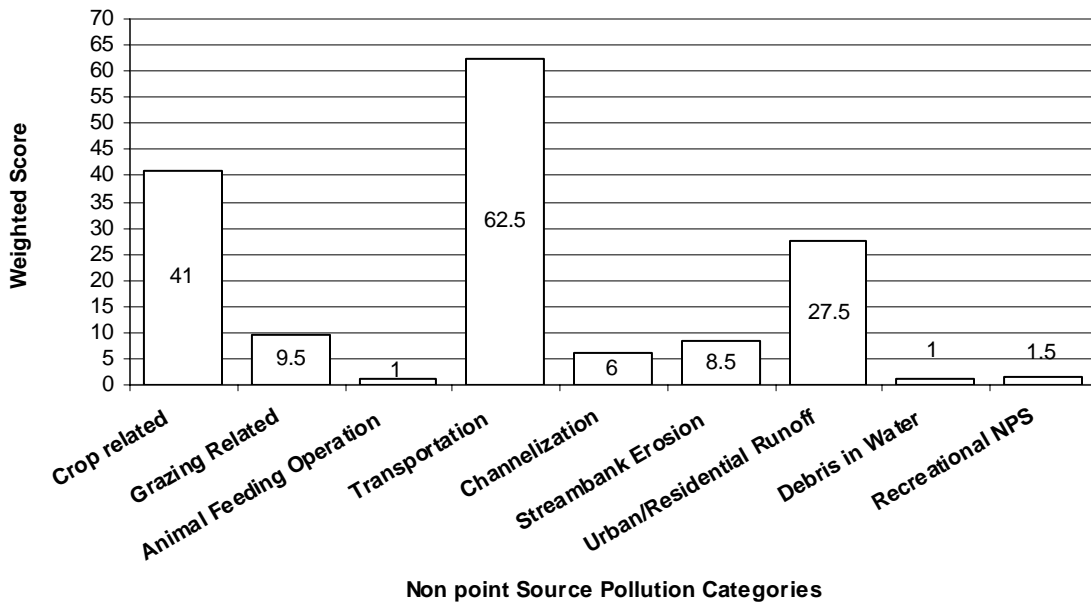
**Figure 9. Weighted values for possible sources of non point source pollution
(cumulative score for all locations)**

During the completion of the road stream crossing surveys, field staff also evaluated the *potential* for non point source pollution. This assessment focuses on the severity of *potential* pollutant *inputs*, not pollutant *impacts*. As part of this evaluation process field staff looks for 1.) a possible pollutant source, 2.) a potential pathway to the waterbody and 3.) potential severity of the input. Because each potential source was given a ranking of slight, moderate and high for potential severity, the values that were recorded were weighted before they were summed for each category (Refer to Figure 9, Attachment B). Observations recorded as slight were considered to be the basis for comparison, therefore observations recorded as moderate were multiplied by 1.5 and observations recorded as high were multiplied by 2. Potential non point source pollution from transportation, crop related sources and urban residential runoff were the most serious while streambank erosion and grazing related sources were also considered common sources of NPS pollution. Refer to Table 5 in Attachment B for a summary of the non point source pollution observations identified for each survey location.
