# GVSU Storm Water Monitoring Data Summary, Progress Report, and Recommendations

Dr. Peter J. Wampler  
Grand Valley State University  
Geology Department

*Final report submitted to GVSU Facilities Management August 2009*

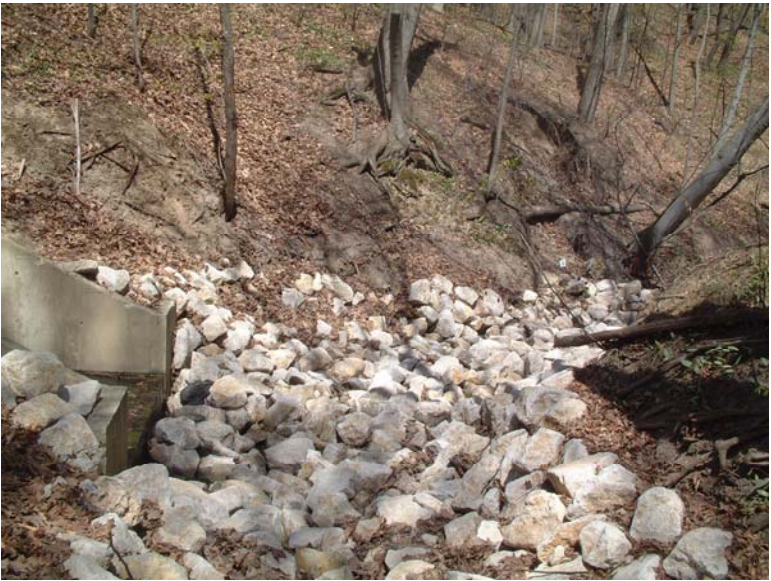
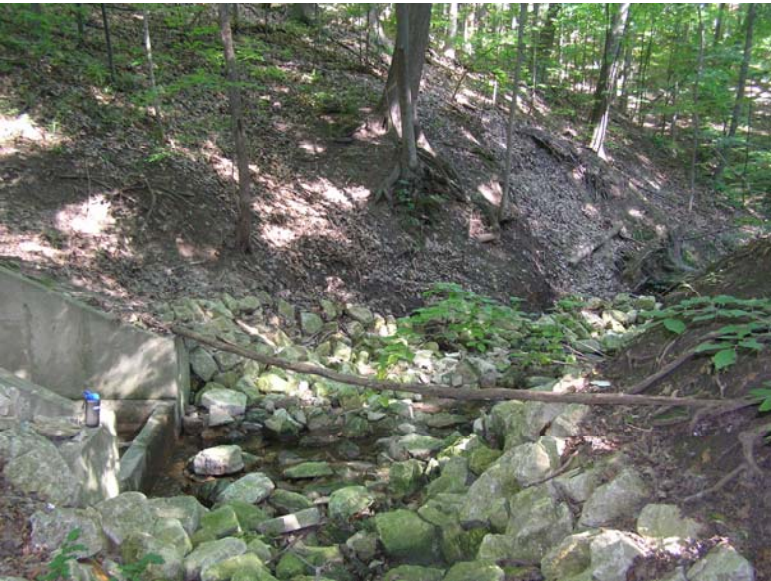
7/31/08	The energy dissipation structure seems to be functioning to dissipate energy. The rip rap channel protection install below the structure us slowly being eroded away and is also mechanically breaking down due to the friability of the limestone chosen for the fill. The mechanical breakdown of the rock has been beneficial in the short term because it has created a wider range of grain size and allowed the materials to key into the channel and prevent future erosion.
Downstream of the Little Mac Ravine Energy Dissipation structure	  4/29/03

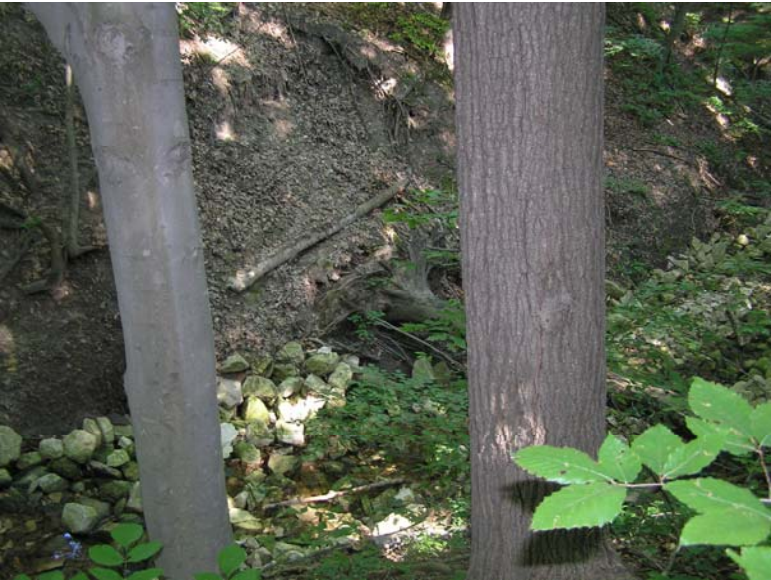
7/31/08	As demonstrated by the photos, the rip rap is not preventing continued erosion of side slopes and slumping of materials down the slope. The tree which was leaning over in 2003 has fallen and is currently spanning the ravine. At this location and others it is clear that during storm events the rip rap is overtopped by water levels.

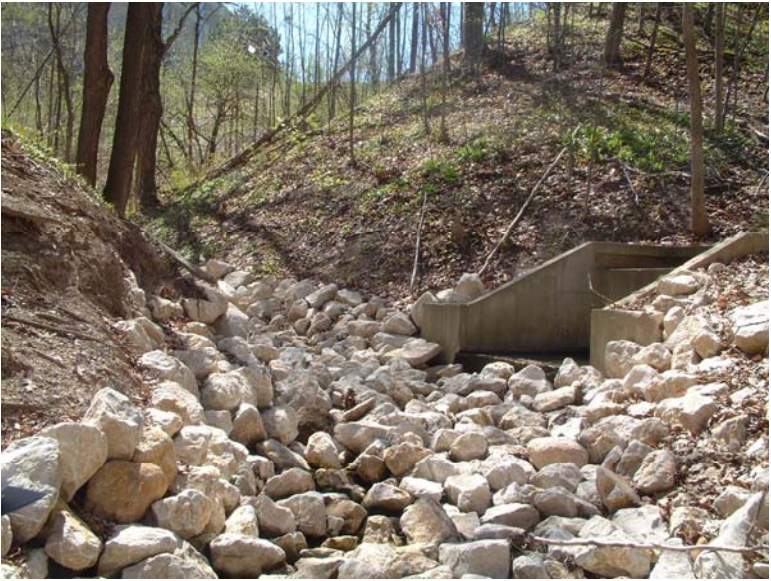
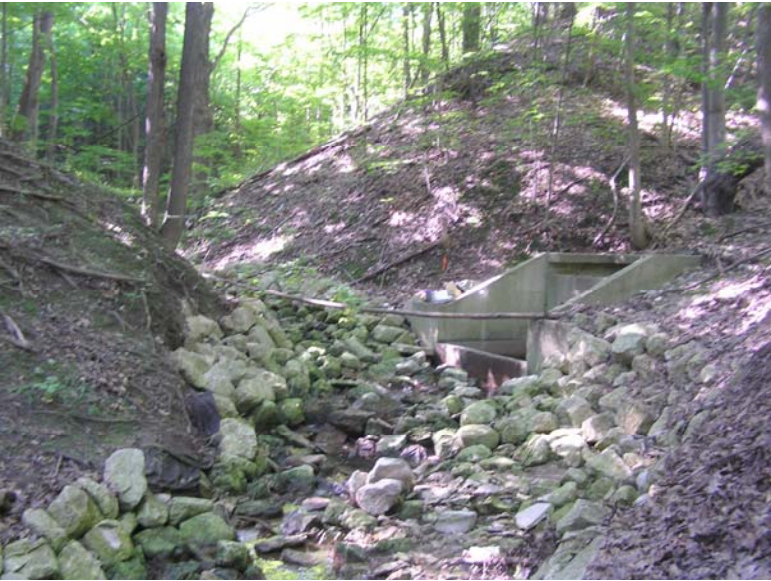
<p>7/31/08</p></div>	This set of photos highlights the channel development due to the settling and mechanical breakdown of the rip/rap materials added to protect the channel from erosion. Algae is also prominent suggesting excess nutrients in the storm water.
Downstream of the Little Mac Ravine Energy Dissipation structure	<div>

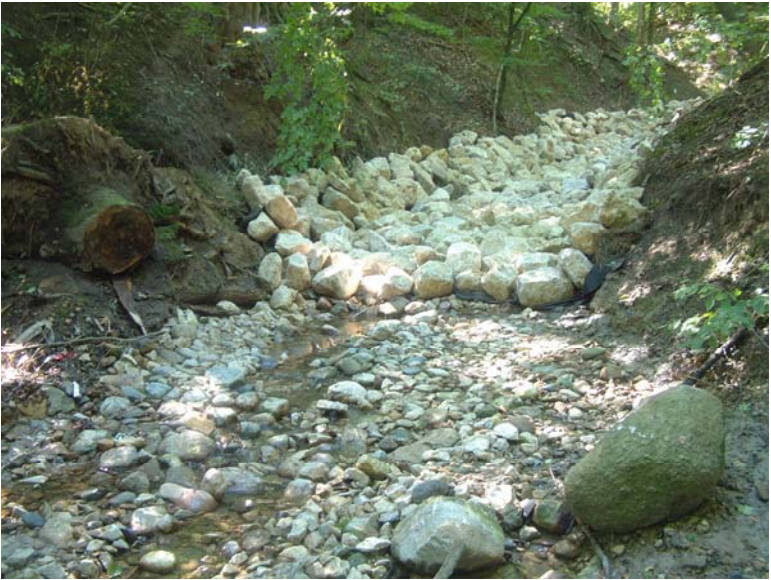
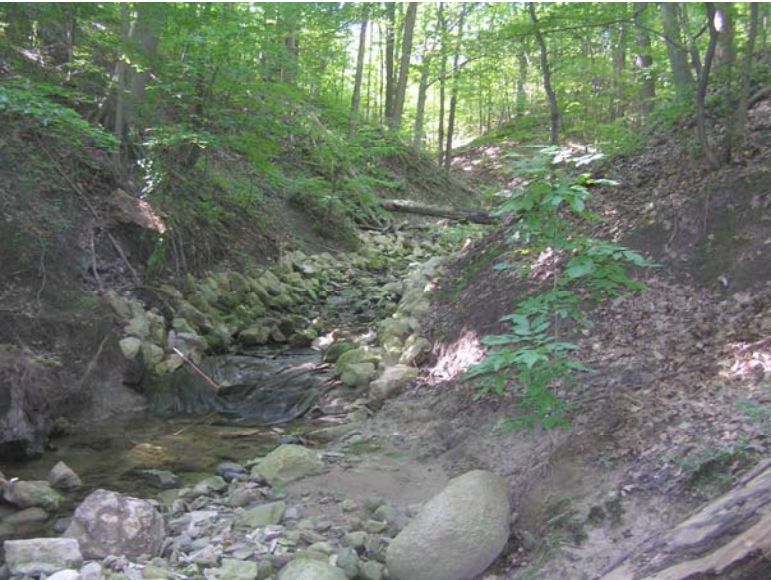
<p>7/31/08</p></div>	The downstream terminus of the rip/rap structure continues to erode away. Rocks are slowly being eroded and removed from the geotextile liner. Smaller rocks and cobbles are being eroded downstream below the channel protection creating a small pool.

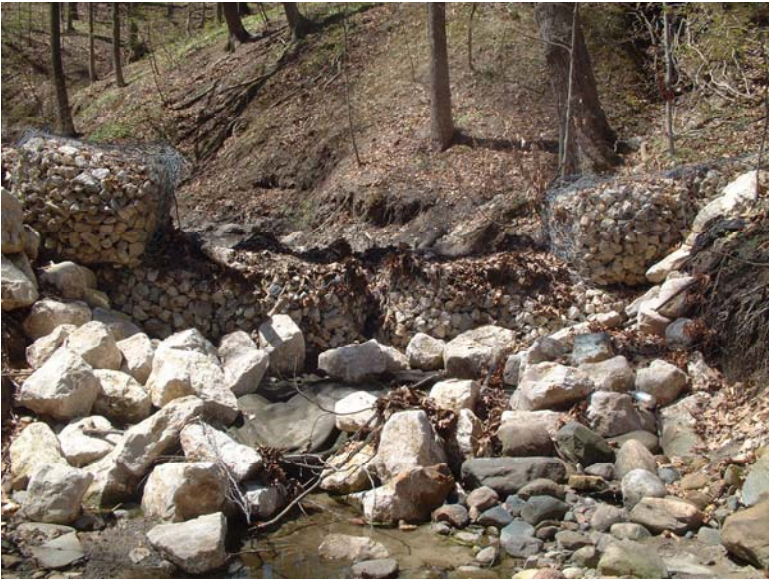
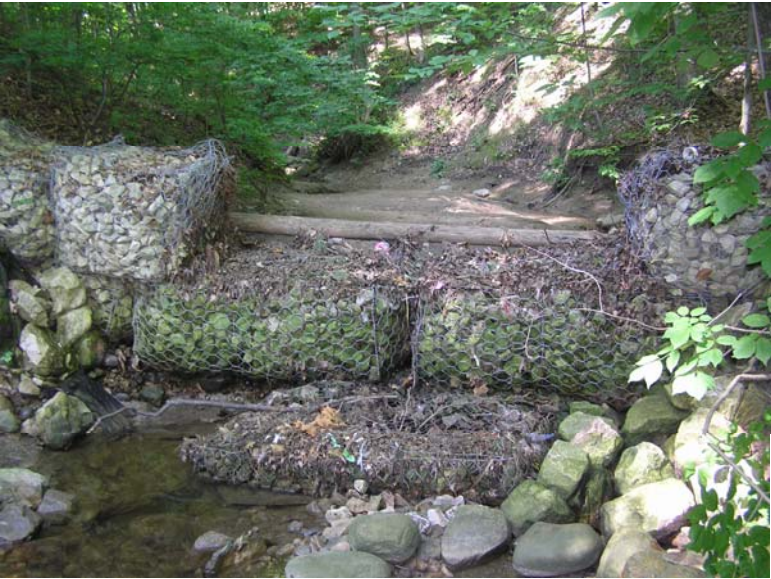
Location	Before (date)	After (date)	Comments
The first Check dame downstream of the Little Mac Ravine Energy Dissipation structure. Looking upstream	<div>

<p>7/31/08</p></div>	This view of the downstream portion of the check dam shows the erosion at the base. This erosion is removing large rocks placed at this location to prevent erosion and will eventually result in undermining and failure of the structure.
Looking downstream from the second check dam	<div>

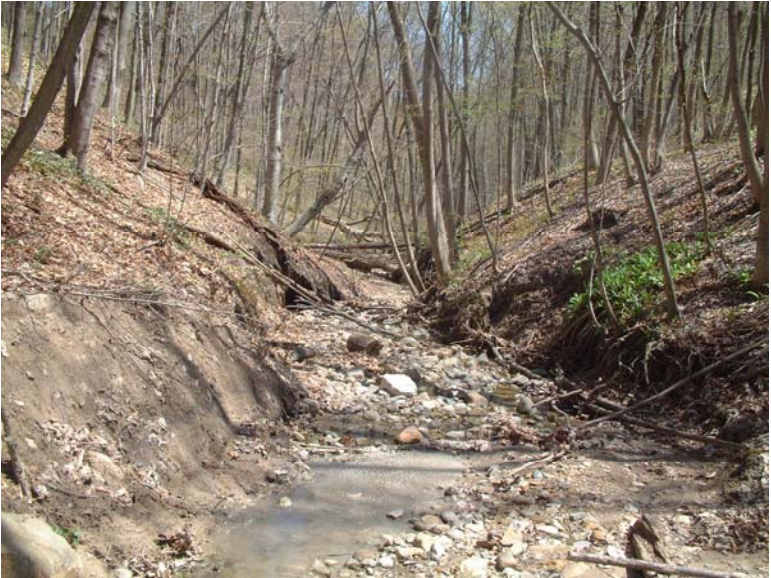
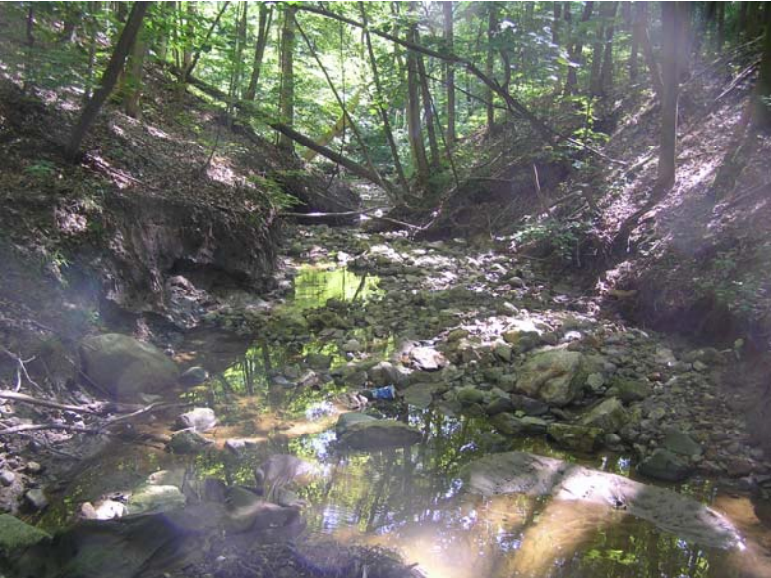
<p>7/31/08</p></div>	Note the dramatic increase in lateral erosion

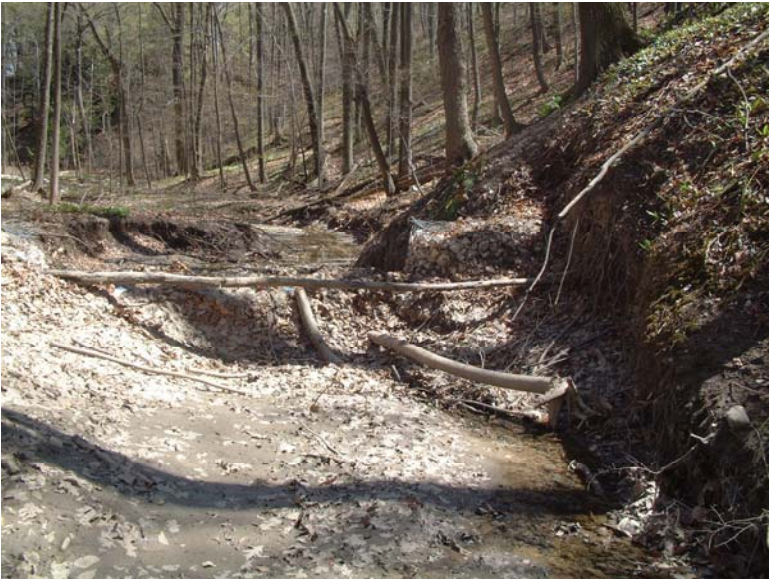
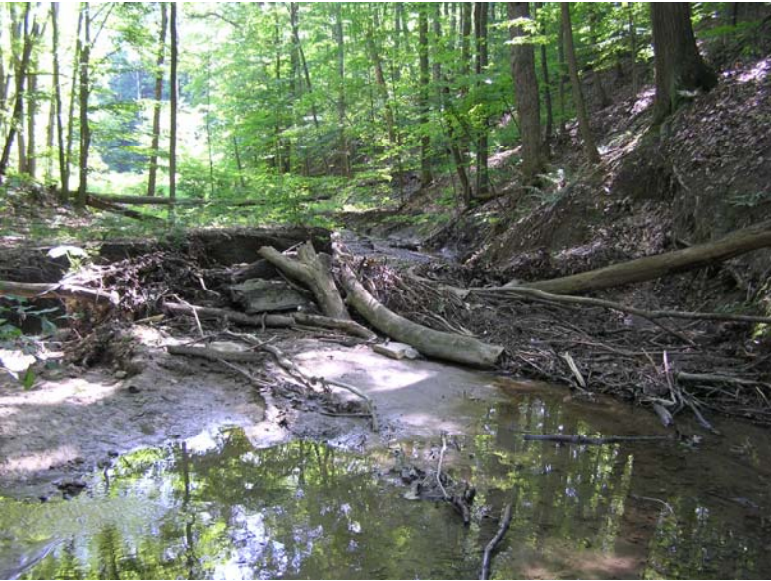
Location	Before (date)	After (date)	Comments
Last check dam in Little Mac Ravine. Looking downstream	<div>

<p>7/31/08</p></div>	Abundant wood debris combined with sedimentation is causing flow to divert around the check dam creating a large waterfall over easily eroded floodplain alluvium on the left. This has resulted in a plunge pool several meters deep and continued lateral erosion.
Last check dam in Little Mac Ravine. Looking upstream	<div>

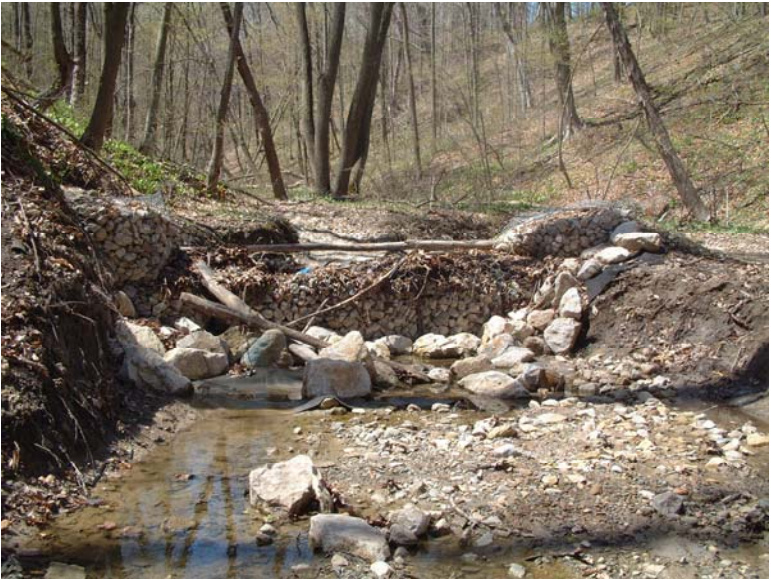
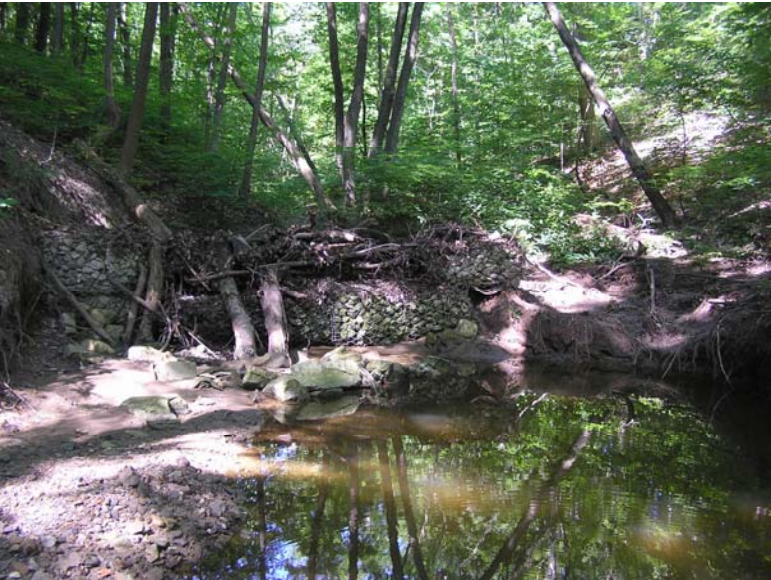
<p>7/31/08</p></div>	Abundant wood debris combined with sedimentation is causing flow to divert around the check dam creating a large waterfall over easily eroded floodplain alluvium on the left. This has resulted in a plunge pool several meters deep and continued lateral erosion.

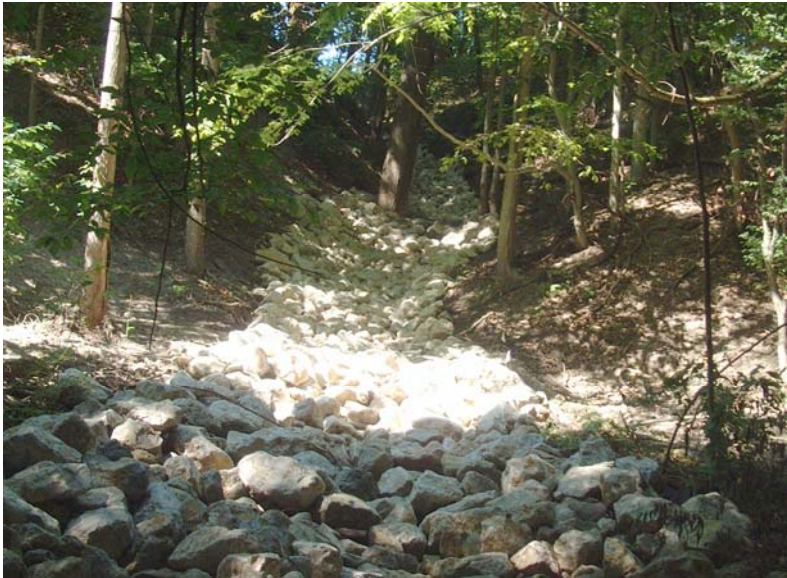
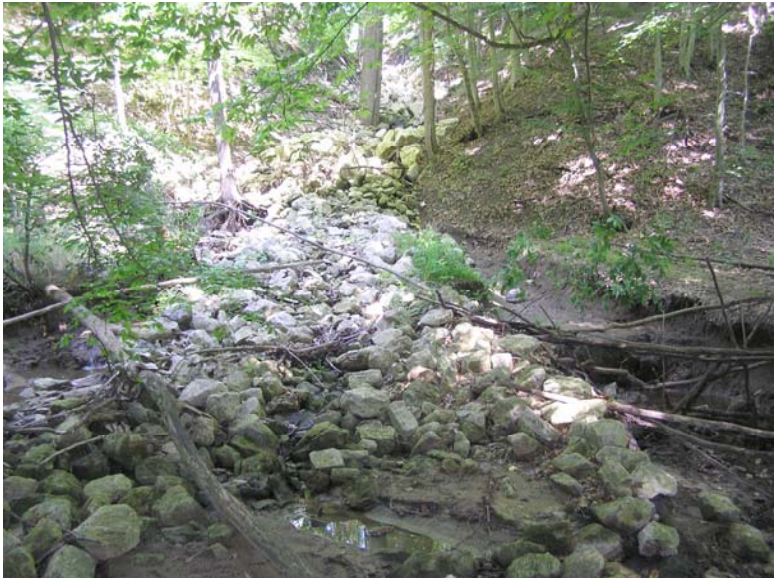
Location	Before (date)	After (date)	Comments
Calder Main Drain below Calder Arts Building. Looking up from the ravine bottom.

7/31/08	The rip rap channel protection installed below the storm water outlet structure continues to be eroded away, especially near the bottom where the flow expands into the ravine floodplain. This has resulted in a 1-2 meter deep gully on the right side of these photos (see below). This process will likely continue to cause lateral erosion.
Calder Main Drain below Calder Arts Building. Looking down on the downstream side of the rip/rap.

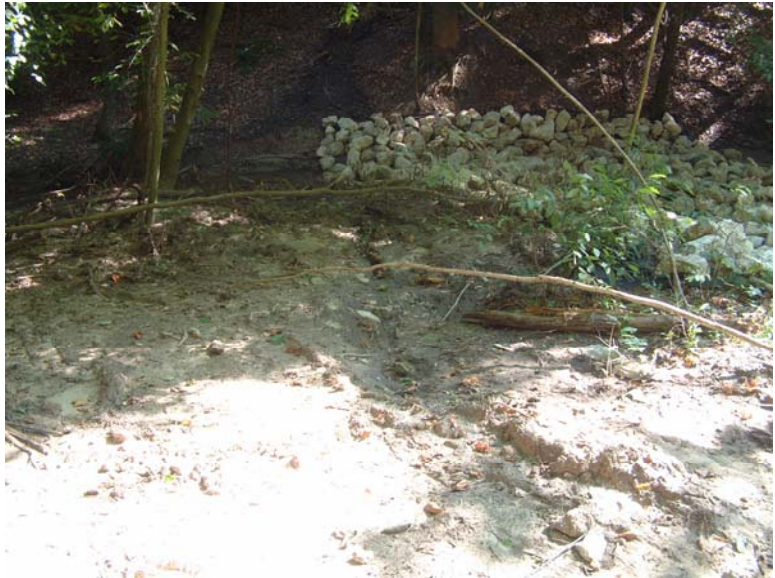
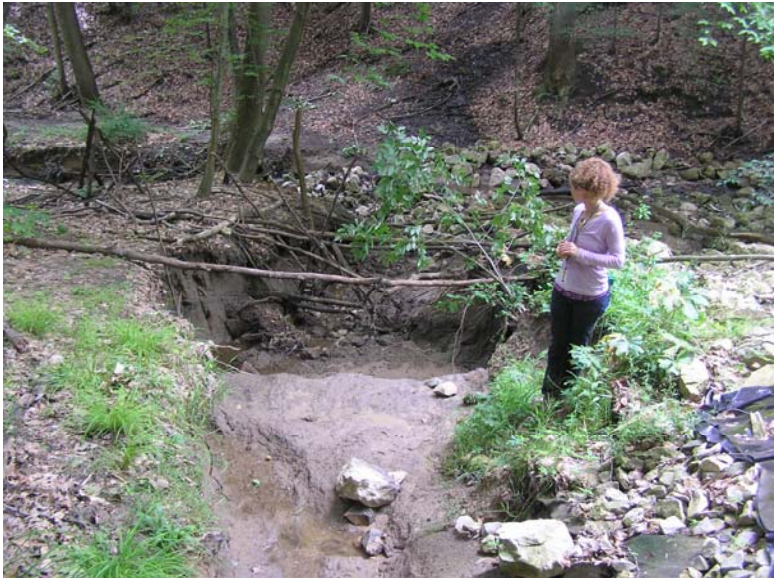
7/11/08	The rip rap channel protection installed below the storm water outlet structure continues to be eroded away, especially near the bottom where the flow expands into the ravine floodplain. This has resulted in a 1-2 meter deep gully on the left side of these photos. This process will likely continue to cause lateral erosion and will eventually undermine all of the rip/rap protection.
