Photo taken August 2009 of the rain garden and monitoring sites located near the Laker Turf Building, GVSU.

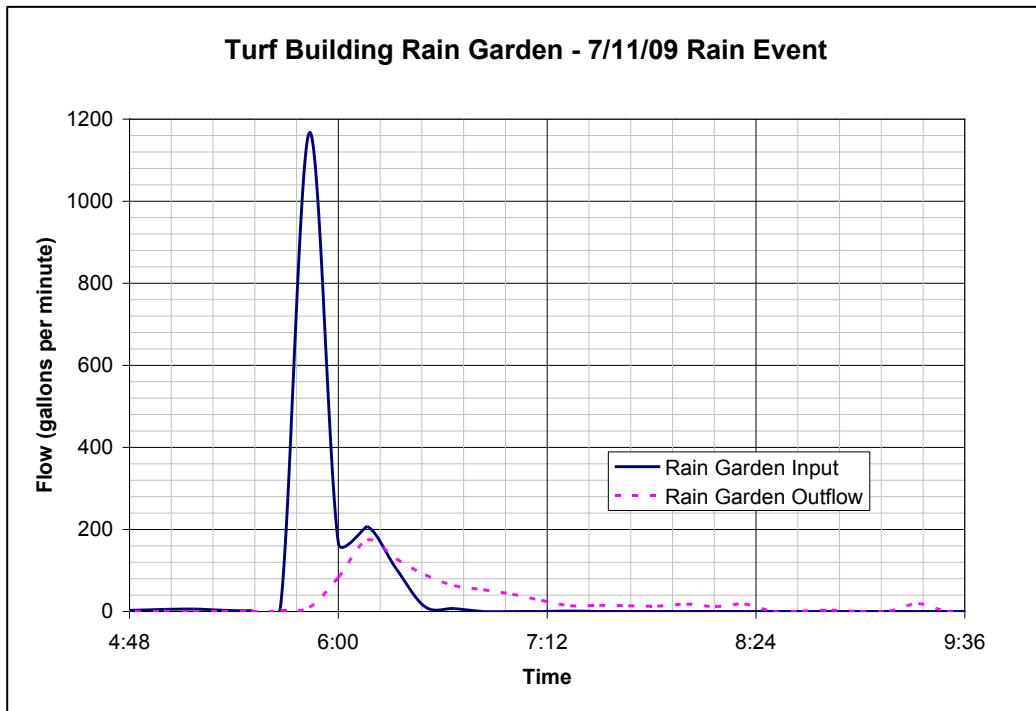
Graph of water flow into and out of the rain garden during a storm event 7/11/09
