# **Urbanization induced changes to a ravine system and evaluation of land use and infrastructure sustainability at Grand Valley State University, Allendale, MI**

Patrick J. Womble

Mentor: Dr. Peter J. Wampler

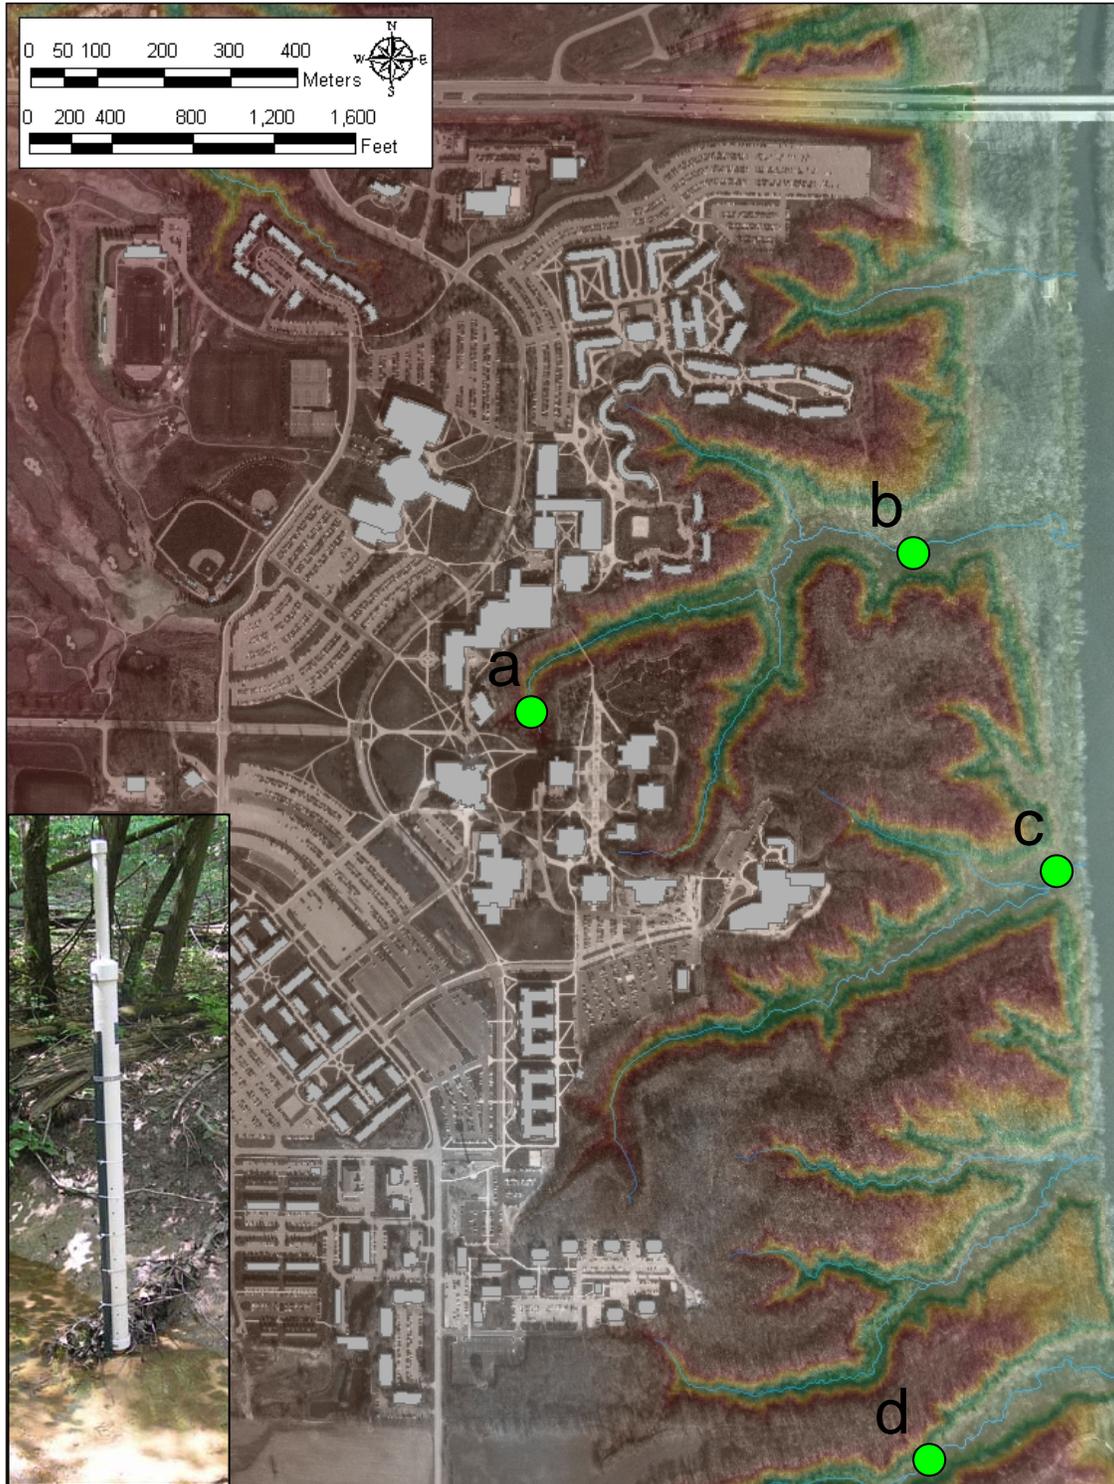
**Fig 4** Map showing the locations of the stream gages a) Mordor; b) Fangorn; c) Isengard; d) Shire and a typical stream gage (inset).

There were two sensors installed in the Little Mac ravine. One sensor, named Mordor, was installed in a concrete dissipation structure located near the head of the ravine to keep track of the volume of water flowing into it. The location of the second sensor, Fangorn, is near the outlet of the ravine and measures the discharge of nearly the entire ravine, including all of the stormwater pipe inputs. The site is located approximately 800 feet upstream from the Grand River to prevent false readings during a potential flooding event.

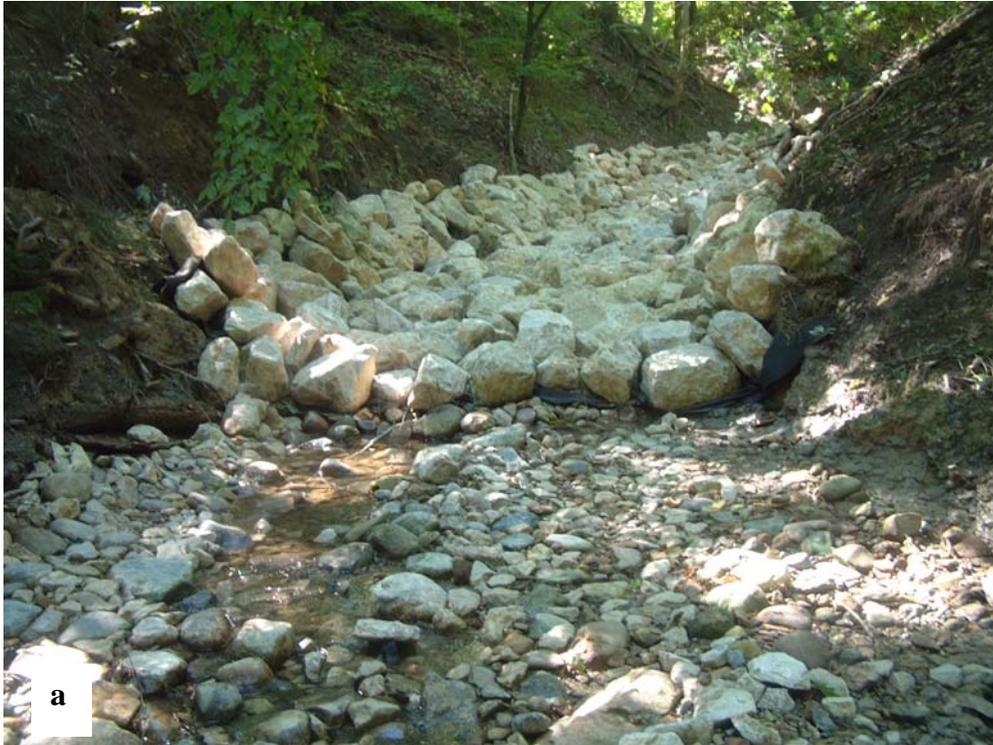
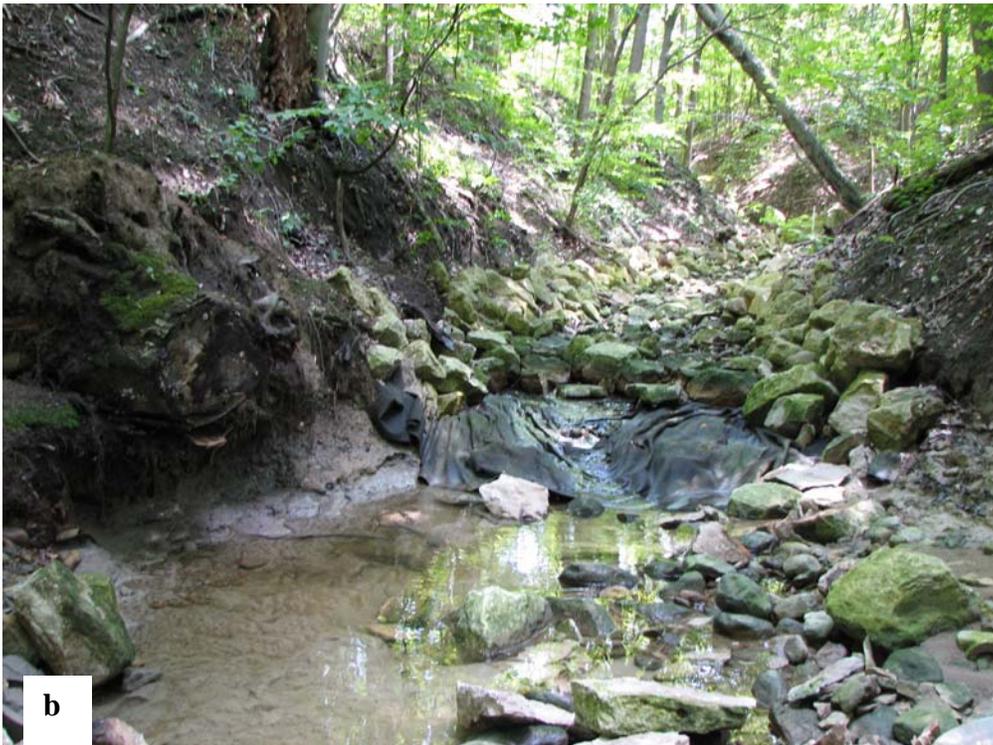
**Fig 19** a) Boulder armoring newly installed in the Little Mac ravine. Photo taken by P. Videtich, 09/03/2002. b) Boulder armoring failure in Little Mac ravine. Photo taken by P. Womble, 07/20/2006.

Boulder armoring sites in the Little Mac and the Calder ravines are no longer structurally sound. The boulders are an argillaceous limestone which has allowed them to cleave along bedding planes, reducing their effectiveness. Infiltration of water underneath the blankets of the boulder armoring has led to unstable conditions of the overlying rock and initiated movement and further erosion (Fig 19a-b). Stormwater has also eroded into more easily erodable materials in the banks adjacent to armored areas. The undermining is worst and most damaging on steep slopes such as the slope near the Calder Art Center Saruman discharge pipe (Fig. 20).

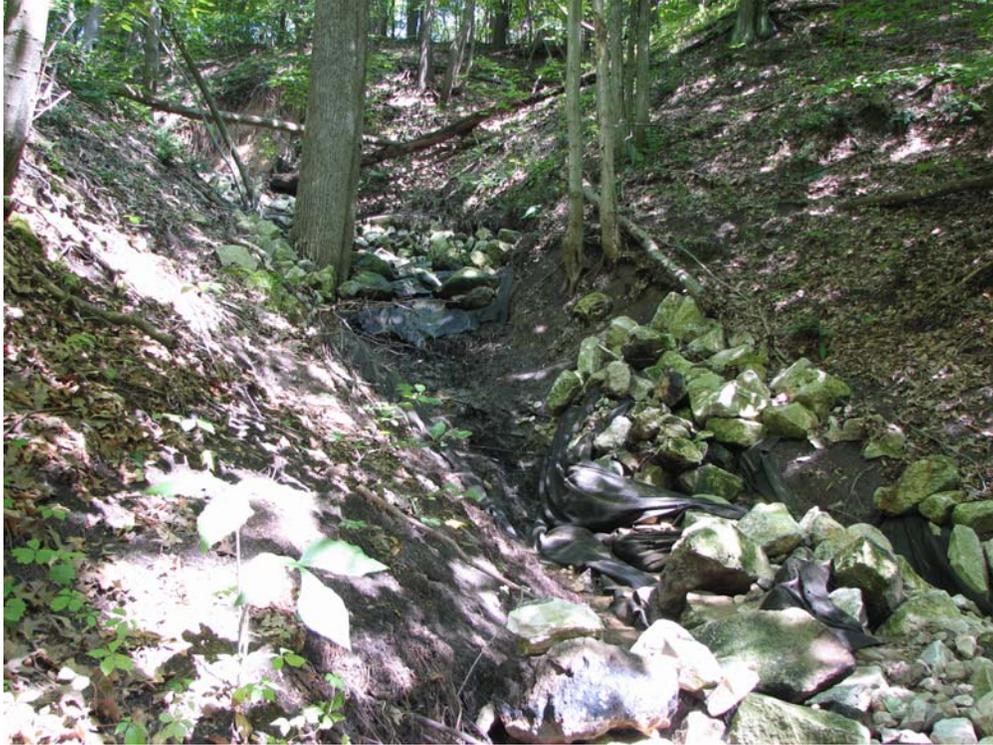
**Fig 20** Boulder armoring failure and underlying blanket mobilization in a ravine tributary just south of the Calder Art Center. Photo taken by T. LaCross, 08/01/2006.

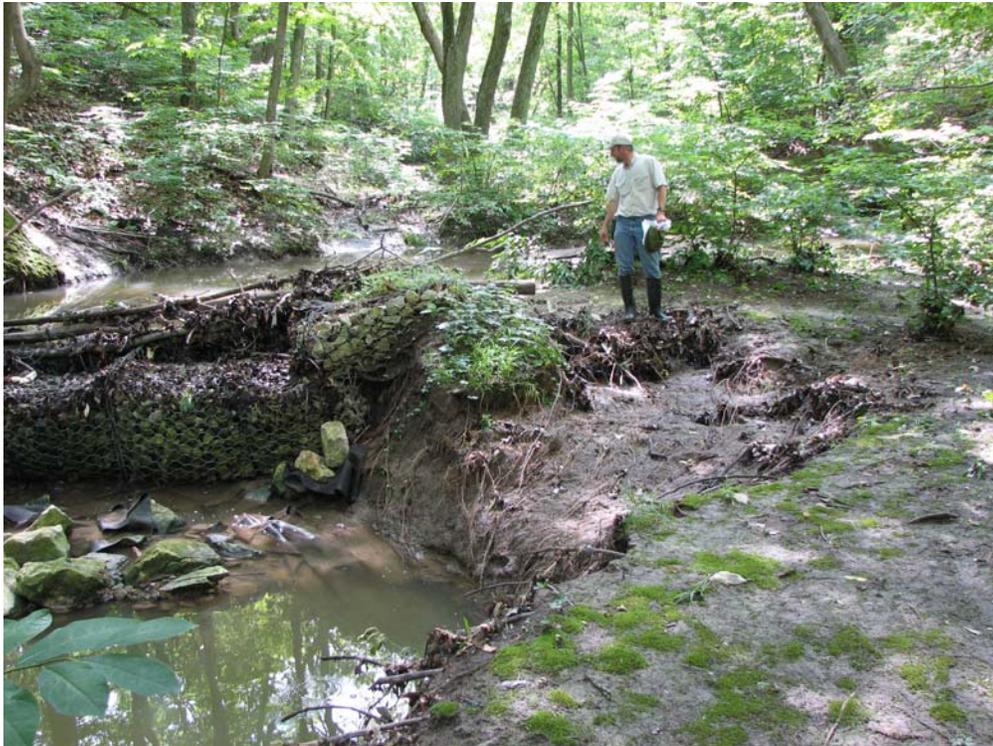
**Fig 21** Lowest check dam in the Little Mac ravine showing increased erosion due to the stream bypassing it during high flow conditions. Photo taken by P. Womble, 07/20/2006.

The check dams installed in the ravine system are also not structurally sound. Baskets are beginning to rust and rocks from inside the baskets are being mobilized and removed into the stream. The baskets are beginning to collapse and in some places create more erosion. There is a large amount of sediment built up behind the second and third check dams in the Little Mac ravine as well as the check dam above the Saruman discharge pipe. The lowest check dam in the Little Mac ravine has just recently been circumvented by water during high flow, causing an erosional channel and pool to form downstream of it (Fig. 21).

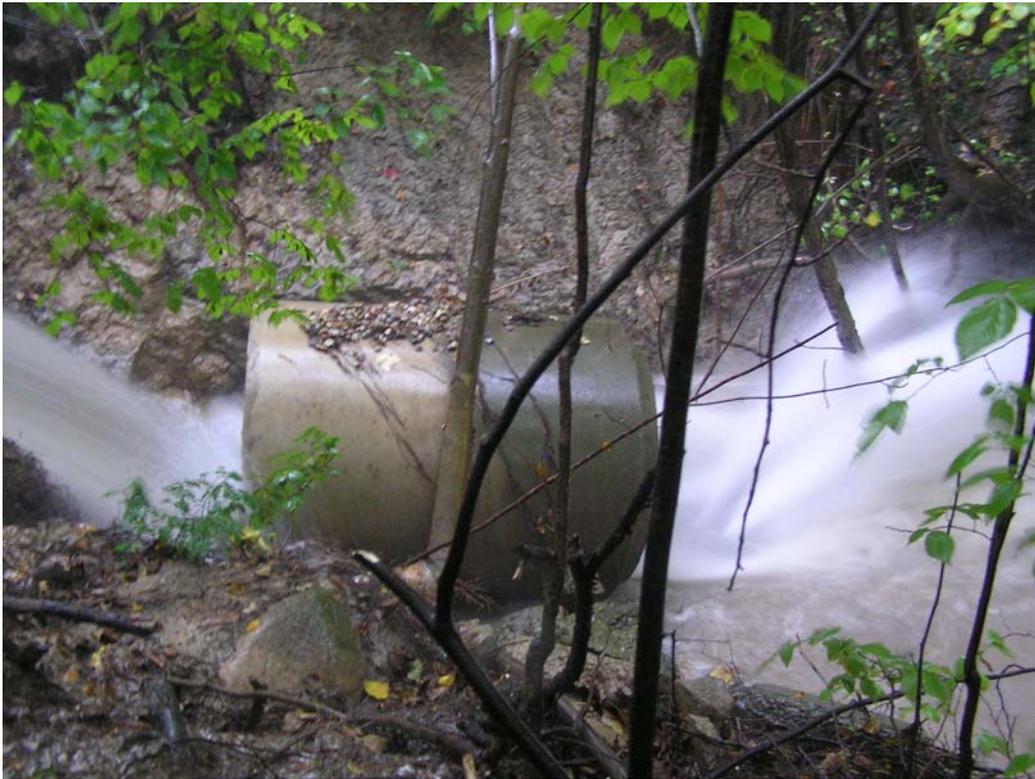
**Fig 22** Discharge in the Ravine apartments ravine during the 9/23/2006 rain event.. Photo taken by P. Wampler on 9/23/2006.

The runoff currently allocated into watershed 3 seems low for the amount of water and erosion observed in the Ravine Apartments ravine during rain events (Fig 22). This is most likely due to the delineation of the watershed and the allocation of stormwater. During the delineation process the watershed generated with the pour points around the Ravine Apartments ravine was merged with the much larger watershed 3. Instead of the increase of water appearing to be dramatic in the small watershed, the water is dispersed over a large area. Also, a possible incorrect allocation of stormwater would decrease the modeled amount of water directed toward the ravine. Therefore, even though there are three large parking lots that drain into that ravine, there is a 9% decrease in peak discharge during a 1 inch per hour rain event.

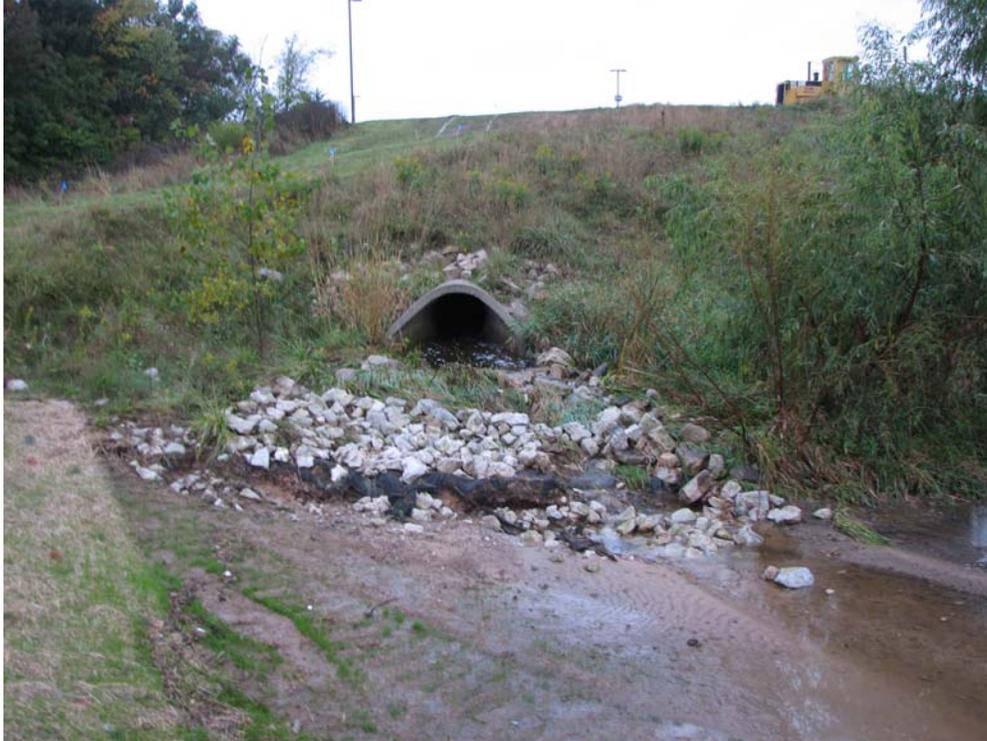
**Fig 23** Discharge pipe into small detention pond at the eastern end of parking lot D in watershed 22 (Photo taken by P. Womble, 09/23/2006).

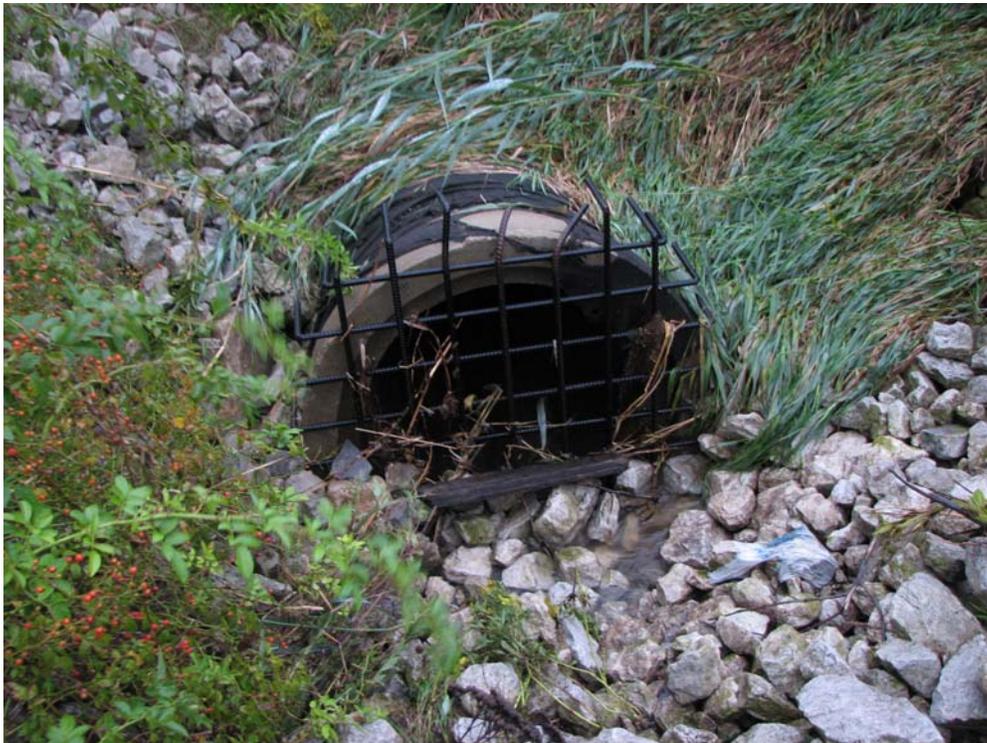
**Fig 24** Outlet drain of small detention structure at the eastern end of parking lot D (Photo taken by P. Wampler, 9/23/2006)

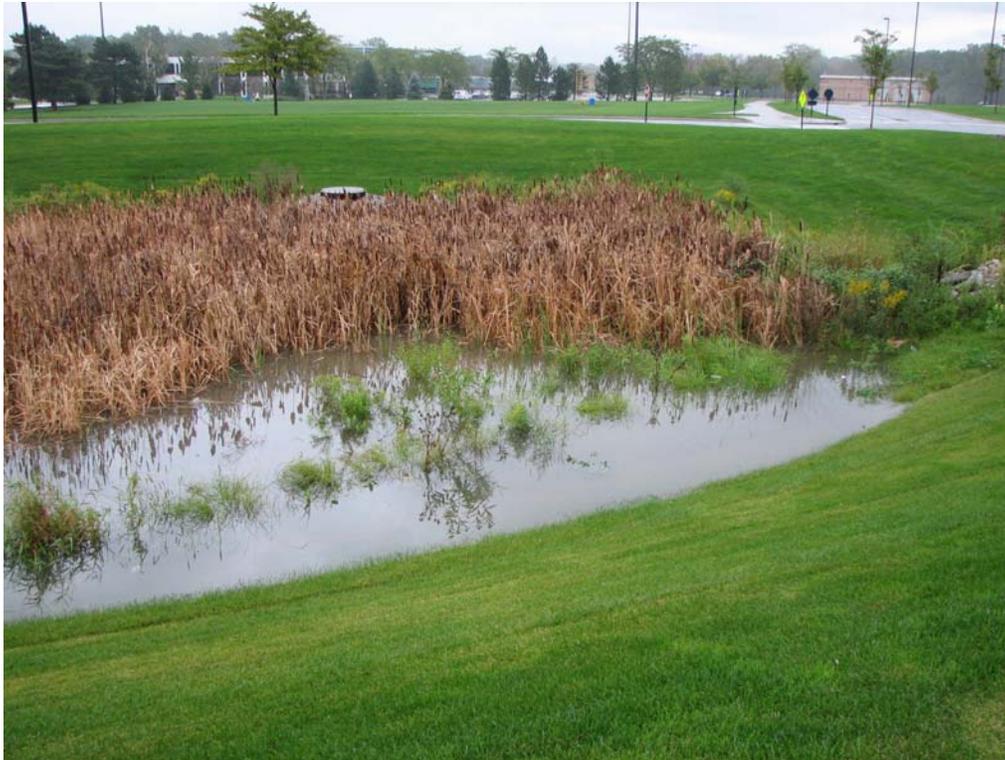
**Fig 25** Stormwater detention structure located at the intersection of South Campus Dr. and Calder Dr. partially full of water. Photo taken by P. Womble, 09/23/2006.
