Total Suspended Solids, Stable Flow, and Wet Weather Event  
Monitoring in the Bass River Watershed

December 2004

The Cadmus Group, Inc.

Submitted to  
U.S. Environmental Protection Agency Region 5

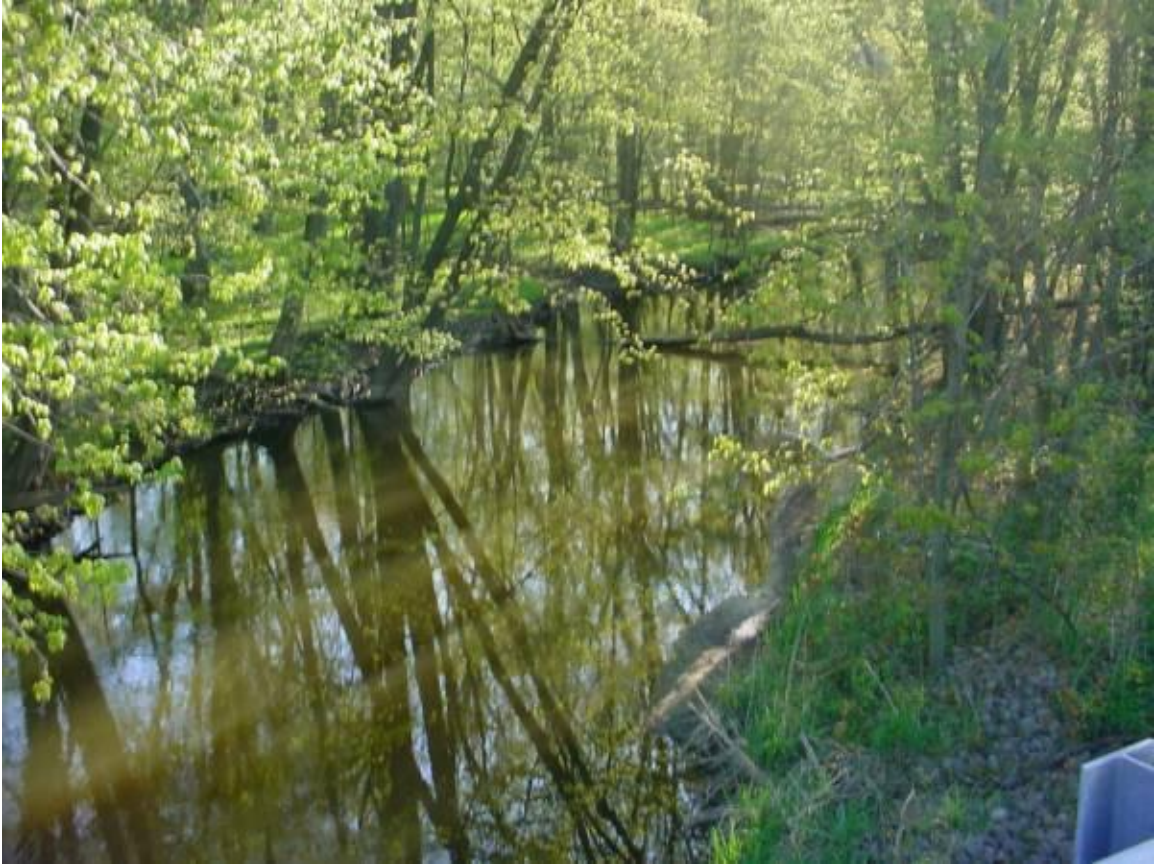
**BR-1 Downstream**

COMMENTS: Measurements taken on the downstream side of the bridge

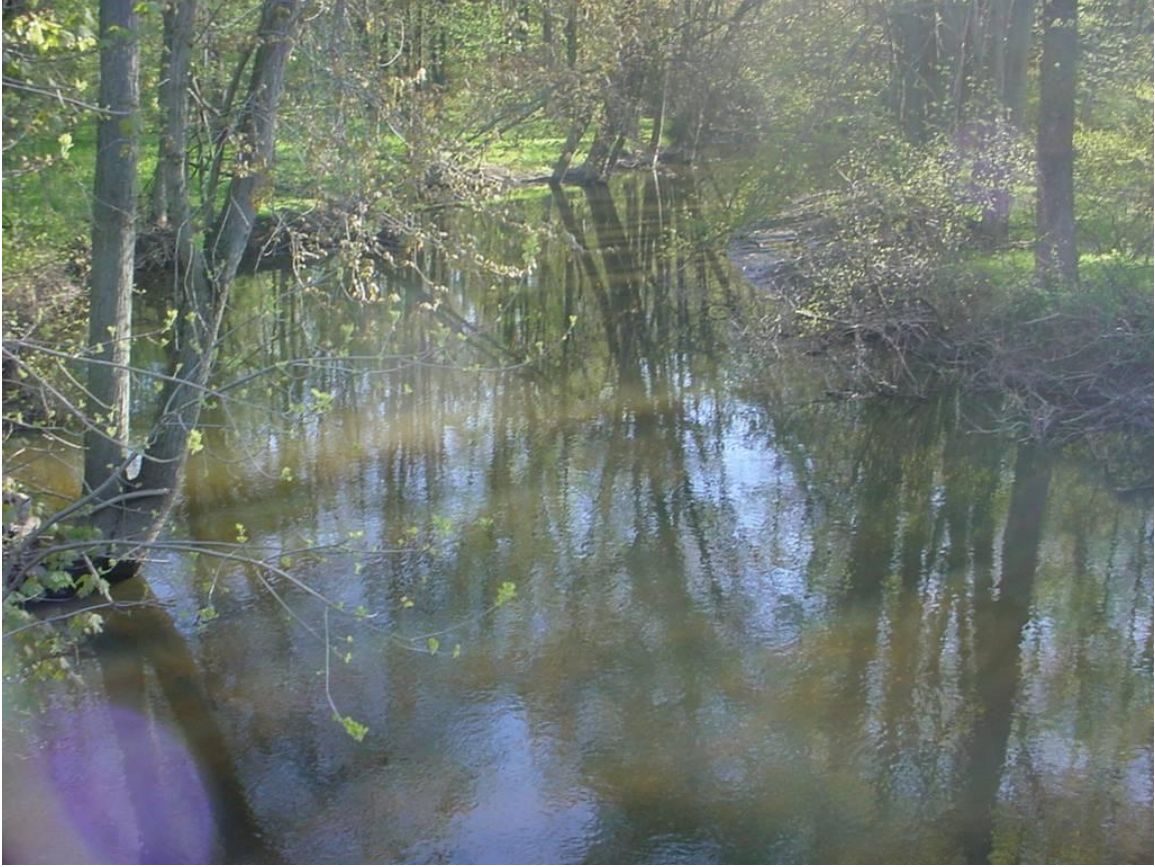
**BR-2 Downstream**

COMMENTS: Sample site downstream from bridge.

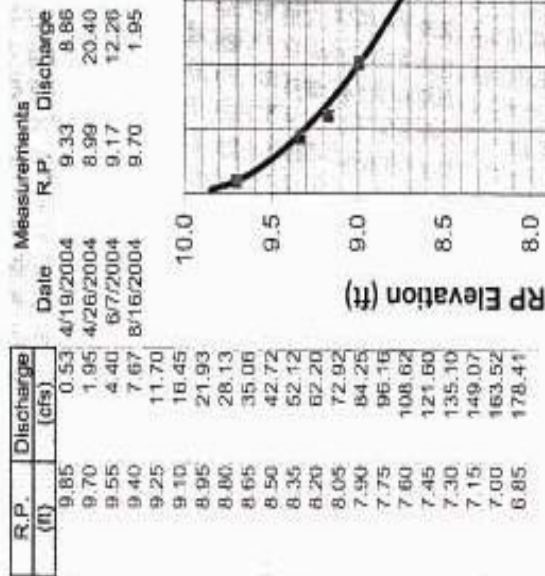
**Station: BR-06, Bass River at Stanton Street**

RP: Downstream side of Bridge a V notched on top of the railing between the 2nd and 3rd railing support from the left edge of water.
