Total Suspended Solids, Stable Flow, and Wet Weather Event
Monitoring in the Mill Creek Watershed

December 2004

The Cadmus Group, Inc.

Submitted to
U.S. Environmental Protection Agency Region 5

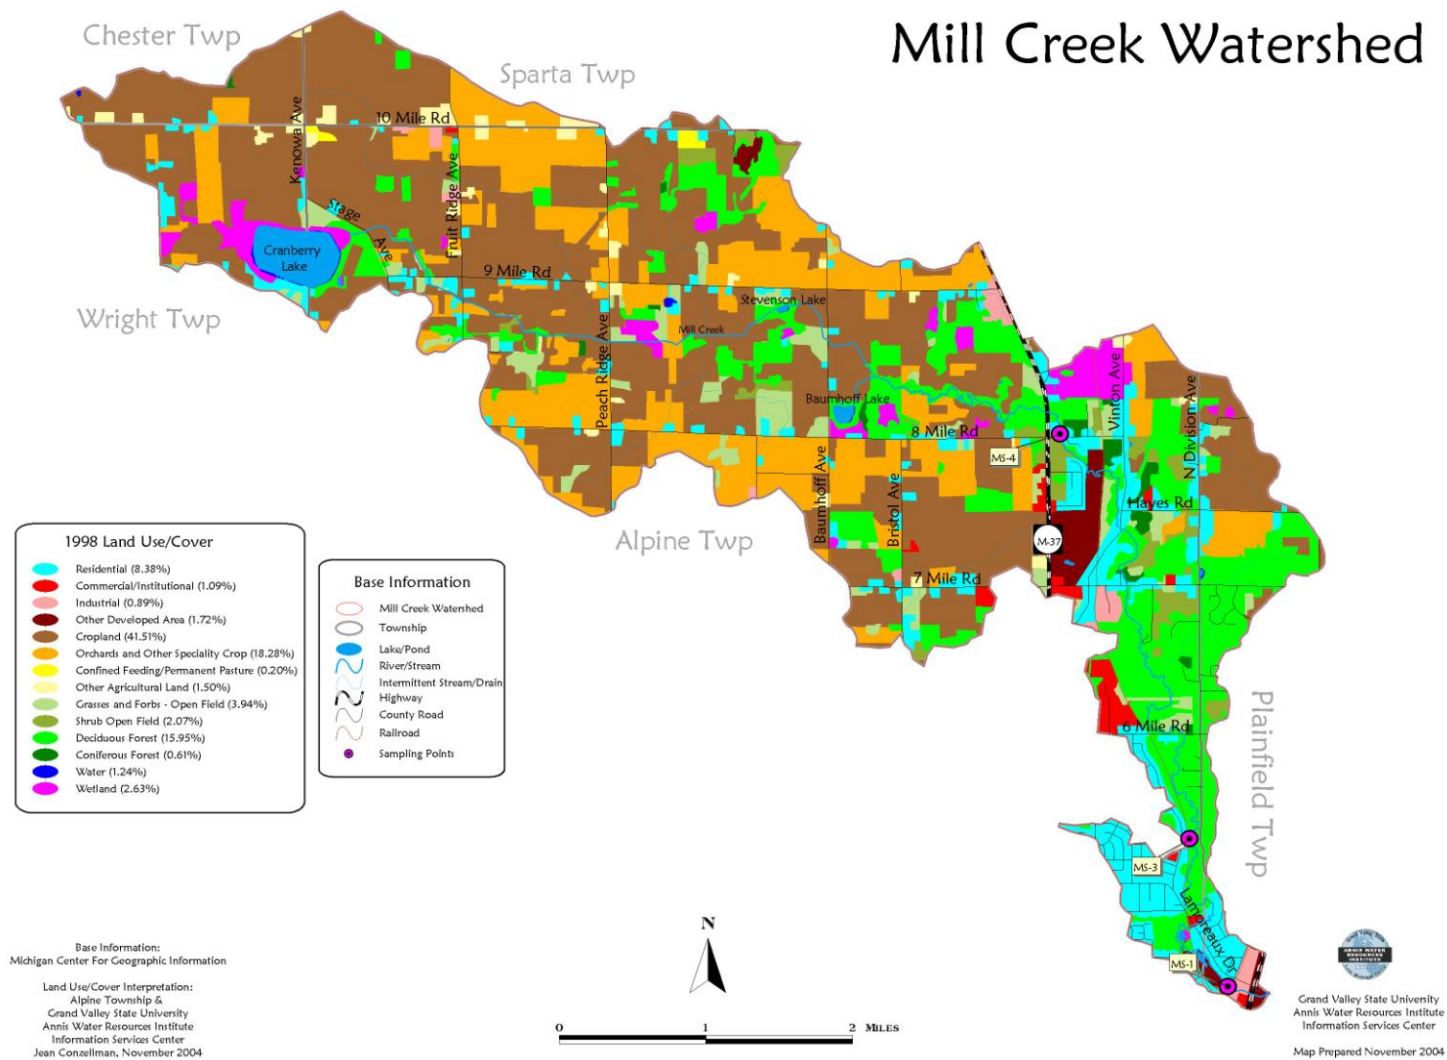
Figure 2.1 Mill Creek Watershed.

Mill Creek has an 11,103 acre watershed located in Kent County (Figure 2.1). Land use in the watershed is primarily agricultural (61%), forests, fields and wetlands (26%), and residential (8%). A summary of land use/and cover statistics is presented in Table 2.1. Stormwater discharge outfalls were inventoried and three stream locations were selected for flow and TSS monitoring (Figure 2.1). Descriptions and coordinates for the stormwater outfalls and monitoring stations are provided in Table 2.2. Strawberry Creek enters the watershed below Station MS-3. Data for the standard Michigan Department of Natural Resources (MDEQ) Stream Survey Form were collected at each monitoring station. The Stream Survey Forms are included in Appendix 1. Photographs of each monitoring station and stormwater location were taken and included in Appendix 2.

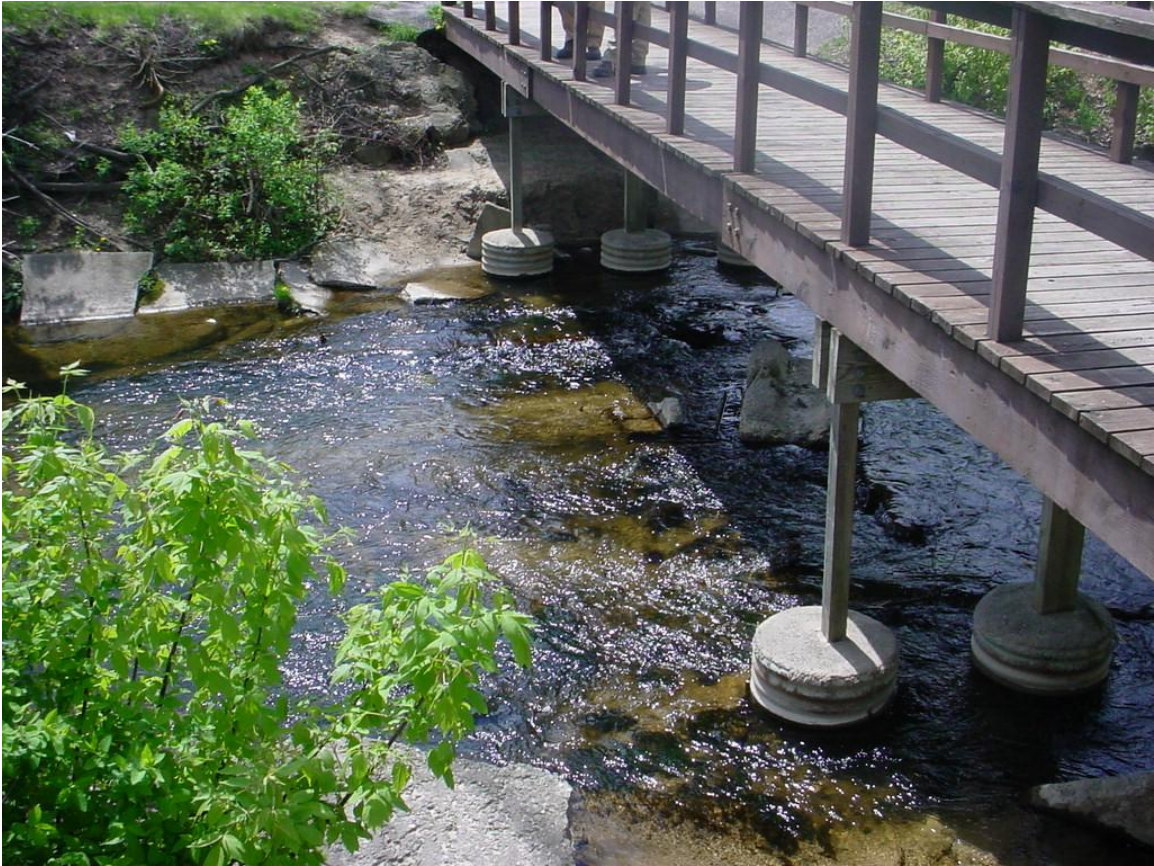
MS-1 Upstream

COMMENTS: Sample sites upstream of bridge.

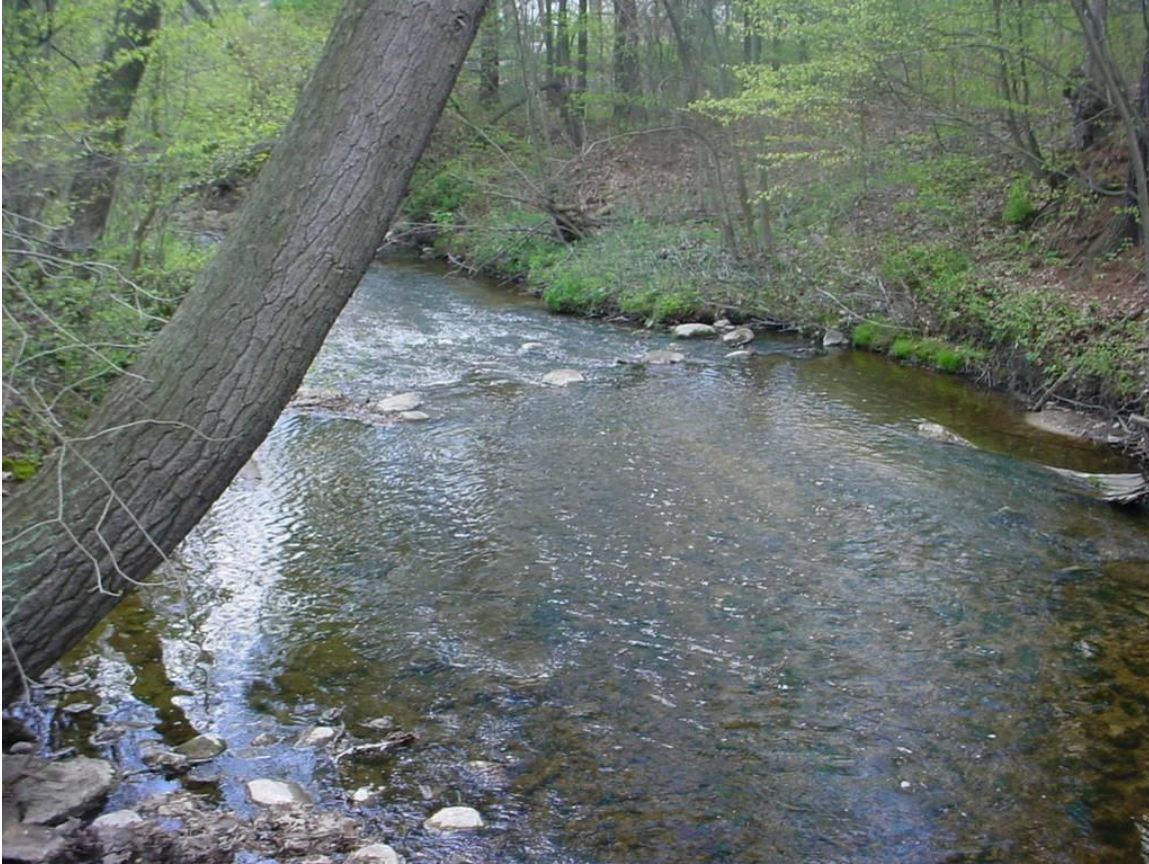
MS-3 Downstream

COMMENTS: Sample site downstream of bridge.

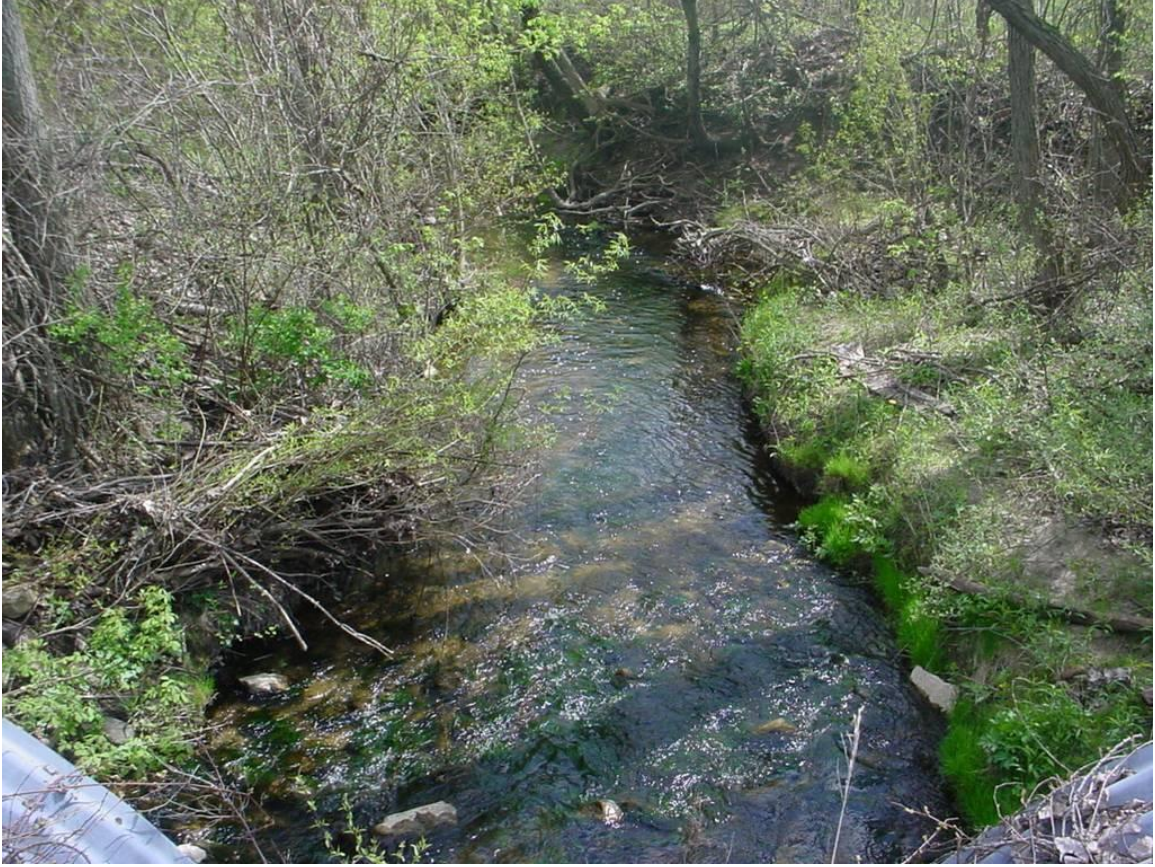
MS-4 Downstream

COMMENTS: Bright, pink root, like aquatic plant. Sample site downstream of bridge.

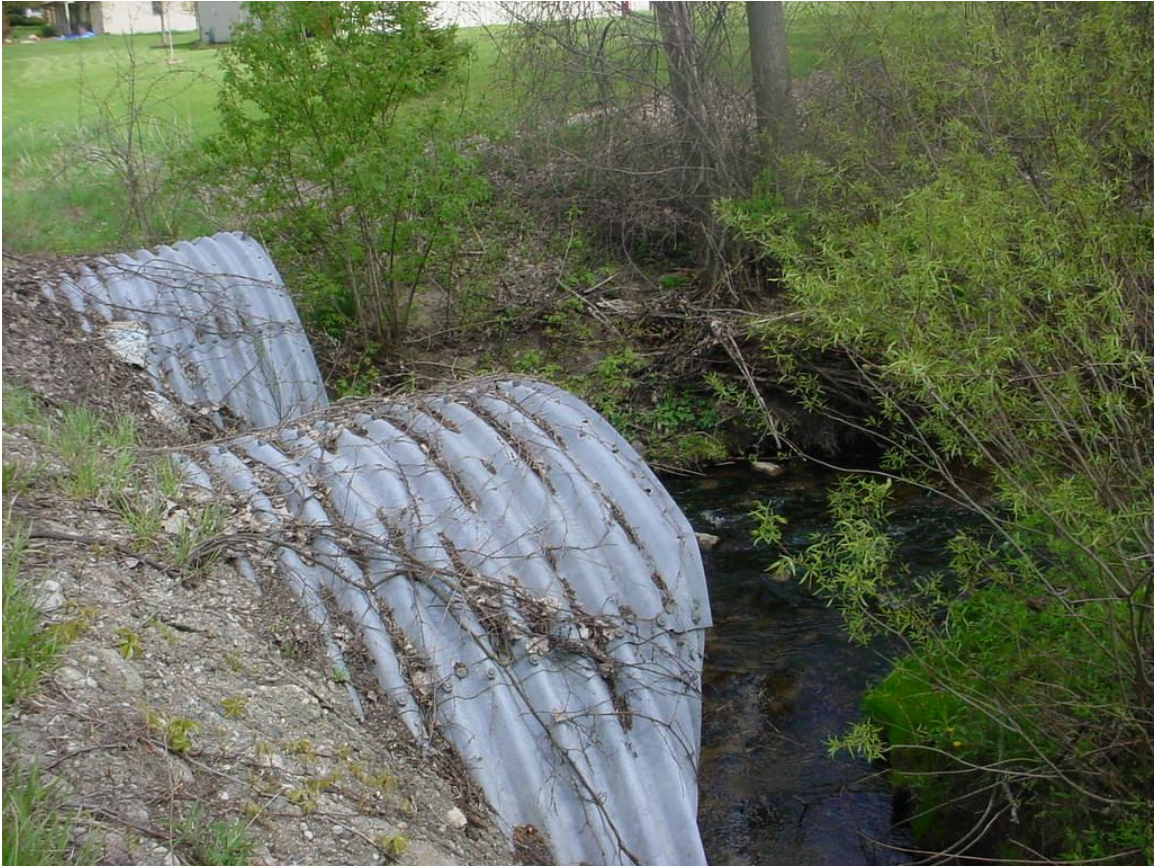
MS-4 Culvert

RP: Downstream side of twin culverts a notched on bend on top of left culvert.

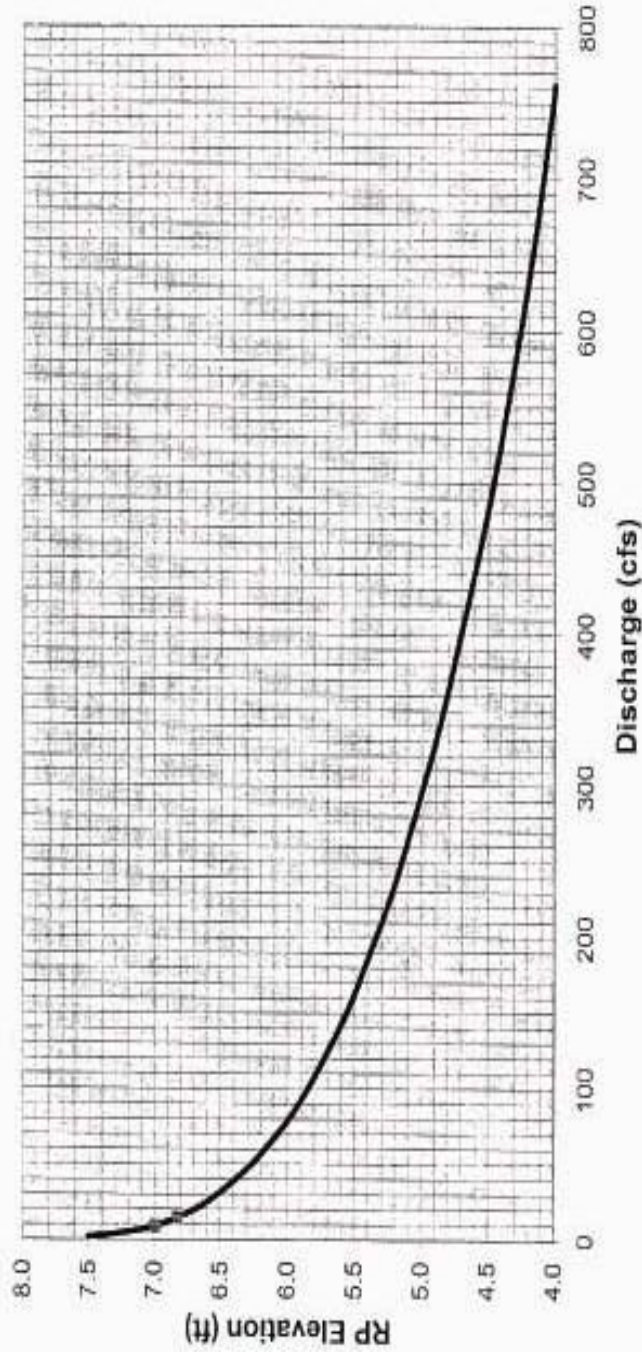
Station: MC-01, Mill Creek at West River Drive

MD Michigan Department of Environmental Quality - Land and Water Management Division
 Stage-Discharge Rating Curve

RP: Downstream side of foot bridge a V notched on the deck of the bridge between the 7th and 8th railing support from the LEW.

R.P. (ft)	Discharge (cfs)	Measurements	
		Date	Discharge
7.50	1.85	4/28/2004	14.6
7.33	3.38	7/24/2004	9.19
7.15	5.72		6.99
6.97	9.60		
6.80	15.35		
6.62	23.74		
6.45	34.98		
6.27	49.34		
6.10	67.18		
5.92	88.90		
5.75	115.53		
5.57	147.86		
5.40	185.68		
5.22	229.49		
5.05	279.68		
4.87	336.74		
4.70	401.14		
4.52	473.34		
4.35	553.83		
4.17	649.25		
4.00	761.99

Base flow and TSS loading data for the Mill Creek watershed are summarized in Table 5.1. Rating Curves developed by the MDEQ for each monitoring station and the location of surface elevation reference points are provided in Appendix 3.

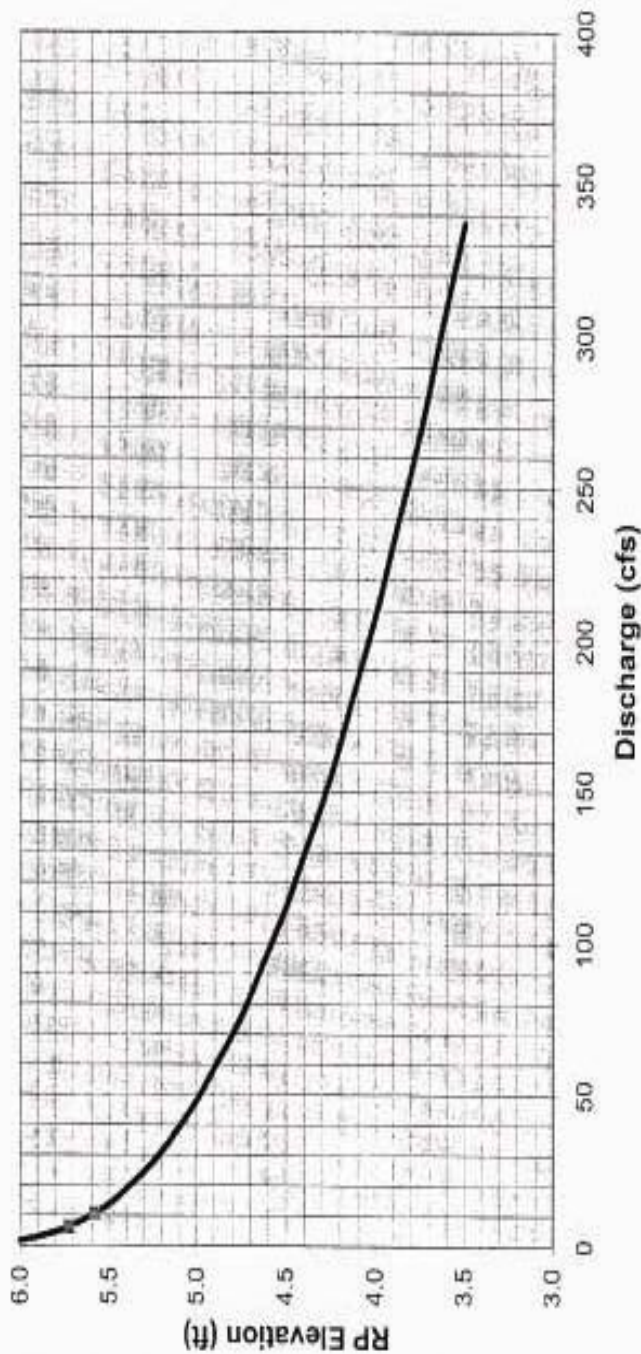
MD Michigan Department of Environmental Quality - Land and Water Management Division
 Stage-Discharge Rating Curve

Station: MC-03, Mill Creek off Division Road at Maranatha Campground
 RP: Downstream side of foot bridge about 10 feet from the left edge of water.

R.P. (ft)	Discharge (cfs)	Measurements		
		Date	Discharge	RP
6	1.58	4/28/2004	10.6	5.58
5.88	3.14	7/29/2004	6.3	5.72
5.75	5.57			
5.63	9.05			
5.5	13.78			
5.38	19.9			
5.25	27.58			
5.13	36.93			
5	48.06			
4.88	61.06			
4.75	75.99			
4.63	92.9			
4.5	111.83			
4.38	132.82			
4.25	155.86			
4.13	180.98			
4	208.16			
3.88	237.4			
3.75	268.68			
3.63	301.97			
3.5	337.26			
3.38	374.52

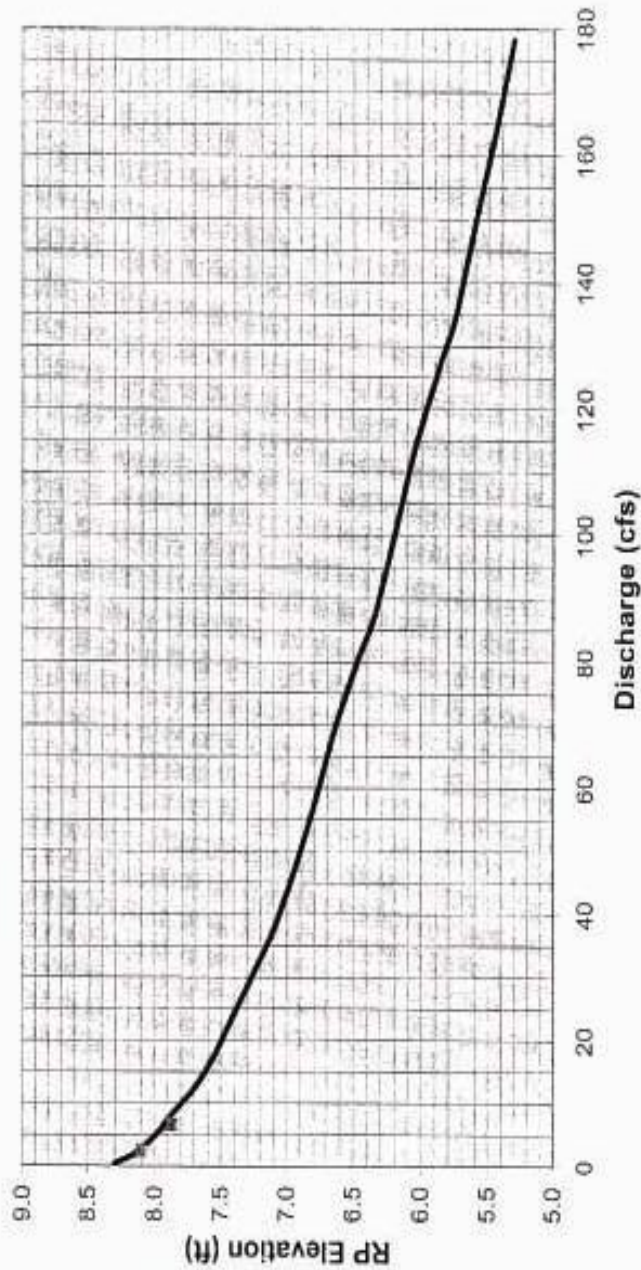
Station: MC-04, Mill Creek at 8 Mile Road

MD Michigan Department of Environmental Quality - Land and Water Management Division
 Stage-Discharge Rating Curve

R.P. (ft)	Discharge (cfs)	Measurements		
		Date	Discharge	RP
8.30	0.40	4/28/2004	5.70	7.87
8.15	1.96	7/29/2004	2.42	8.10
8.00	4.78			
7.85	8.74			
7.70	12.40			
7.56	17.08			
7.40	24.18			
7.21	32.50			
7.10	37.50			
6.95	46.72			
6.80	57.06			
6.65	68.62			
6.46	80.68			
6.35	87.00			
6.20	99.84			
6.05	113.36			
5.86	127.18			
5.75	134.30			
5.60	149.00			
5.45	162.92			
5.30	178.26
