Campus Sustainability Week 2011

Ravine Romp and Tour of Storm Water Best Management Practices

October 21, 2011

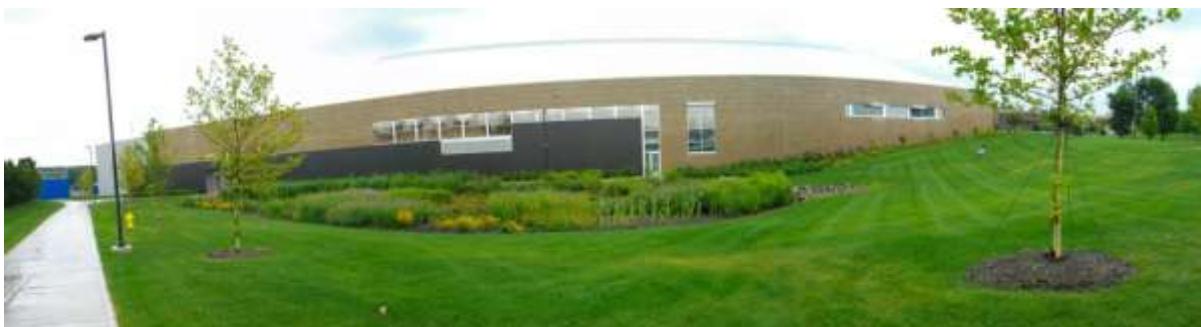
**Figure 3 - Photo taken August 2009 of the rain garden and monitoring sites located near the Turf Building, GVSU.**

In 2007, GVSU faculty, the ad-hoc Storm Water Advisory Group (SWAG), and Fishbeck, Thompson, Carr, and Huber (FTCH) collaborated to draft a comprehensive storm water management plan for the Allendale Campus (FTCH, 2007). This plan included a robust hydrologic model for predicting runoff from various storm water release locations. Facilities improvements over the last several years have been designed to be "runoff neutral." This means that no additional runoff will be directed to the ravines in the process of new building construction. Several best management practices for storm water management have been employed including a large rain garden near the new turf building on the east side of campus. Through a grant from Facilities, flow data has been collected for this large rain garden (Figure 3). Data collected in 2009 suggest this structure is capable of reducing peak runoff rates by over 600 percent (Figure 4).
