Reducing the Storm Water Footprint of GVSU through BMP's

*Ottawa County
Eighth Annual Water
Quality Forum*

*West Olive, MI
November 25, 2013*

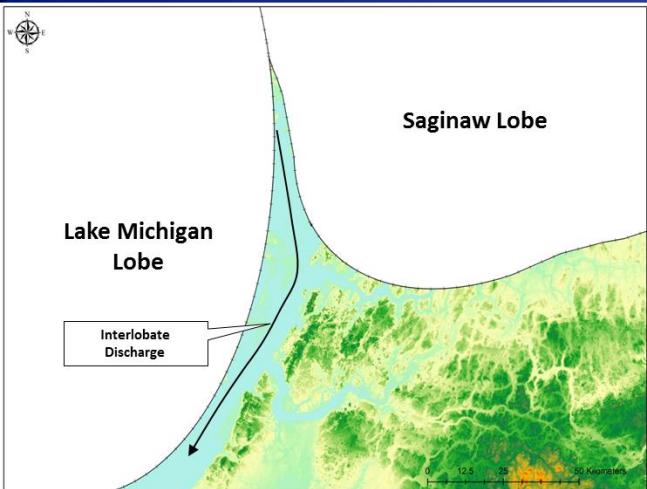
Churches and Wampler (2013)

~ 15,000 years ago

~ 14,000 years ago

~ 13,000 years ago

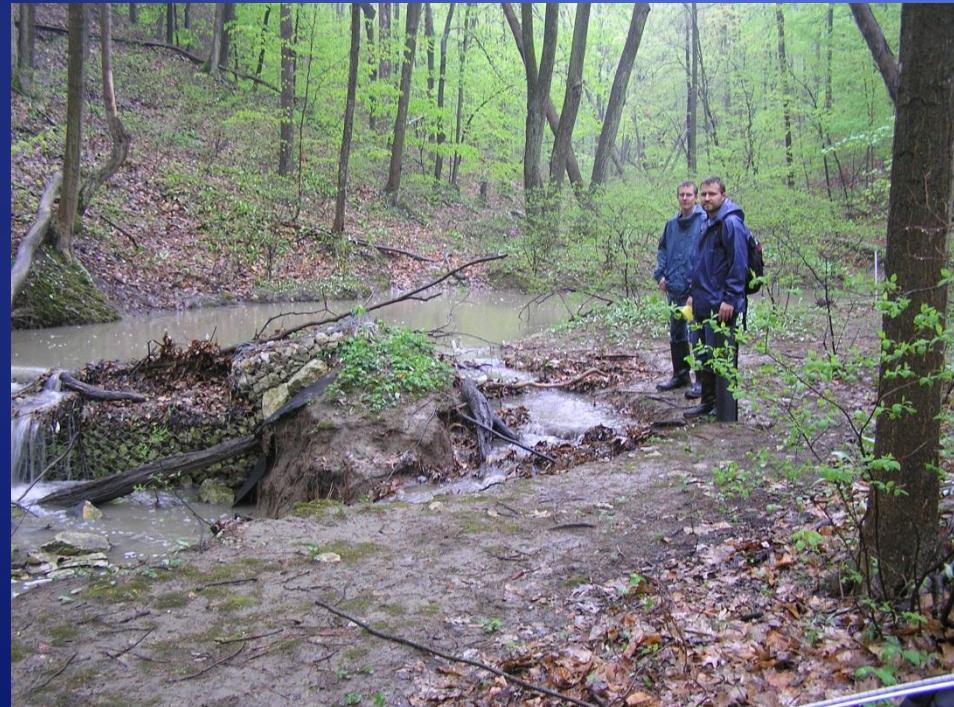
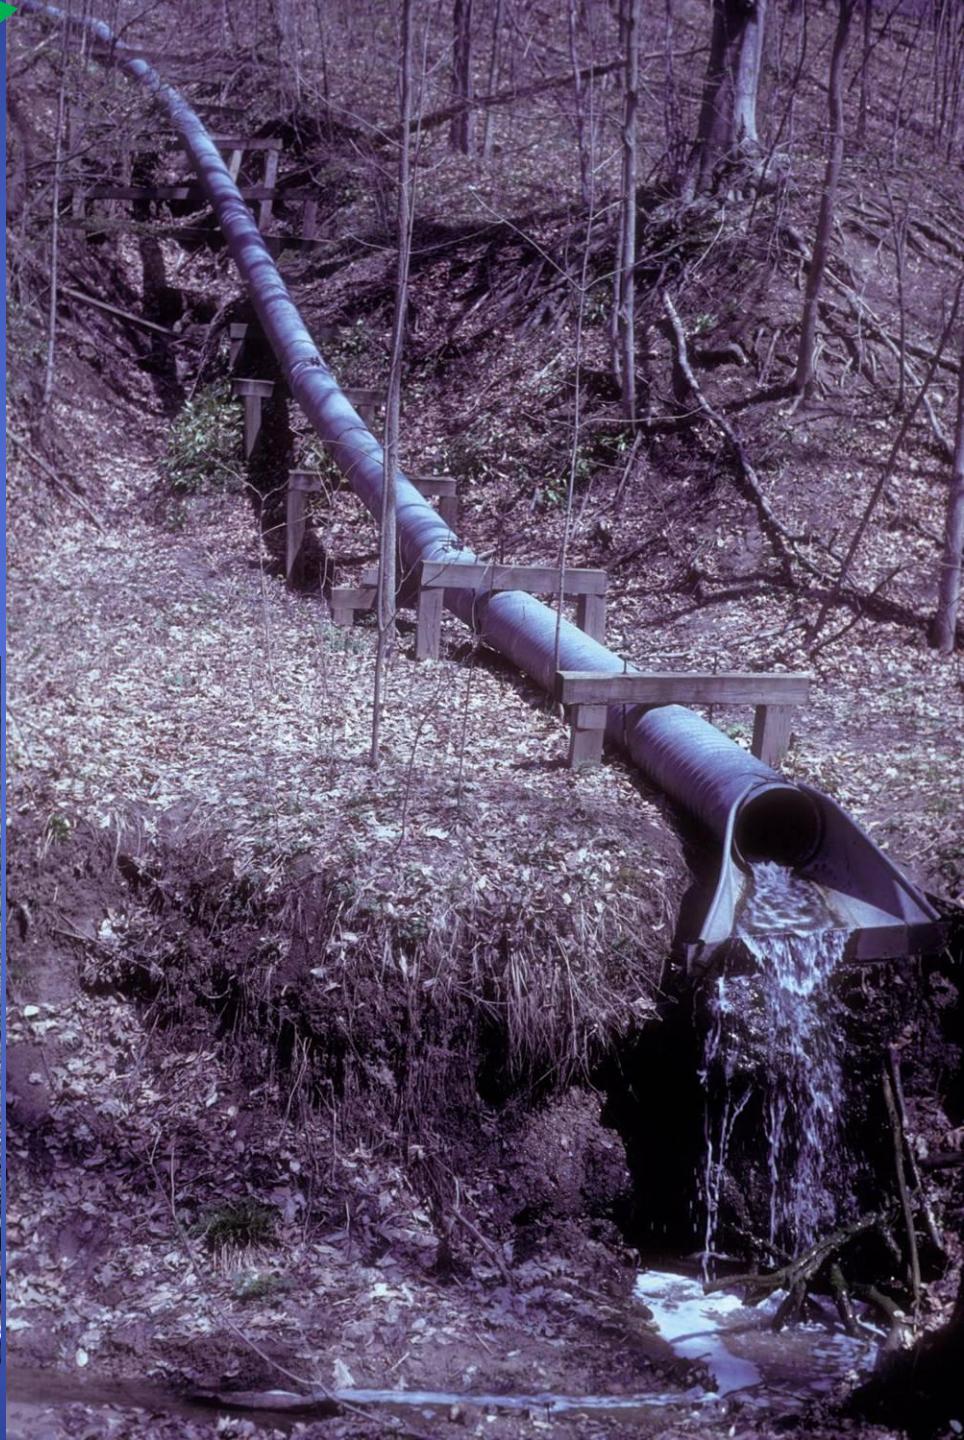
Drainage pipe into ravine behind Padnos

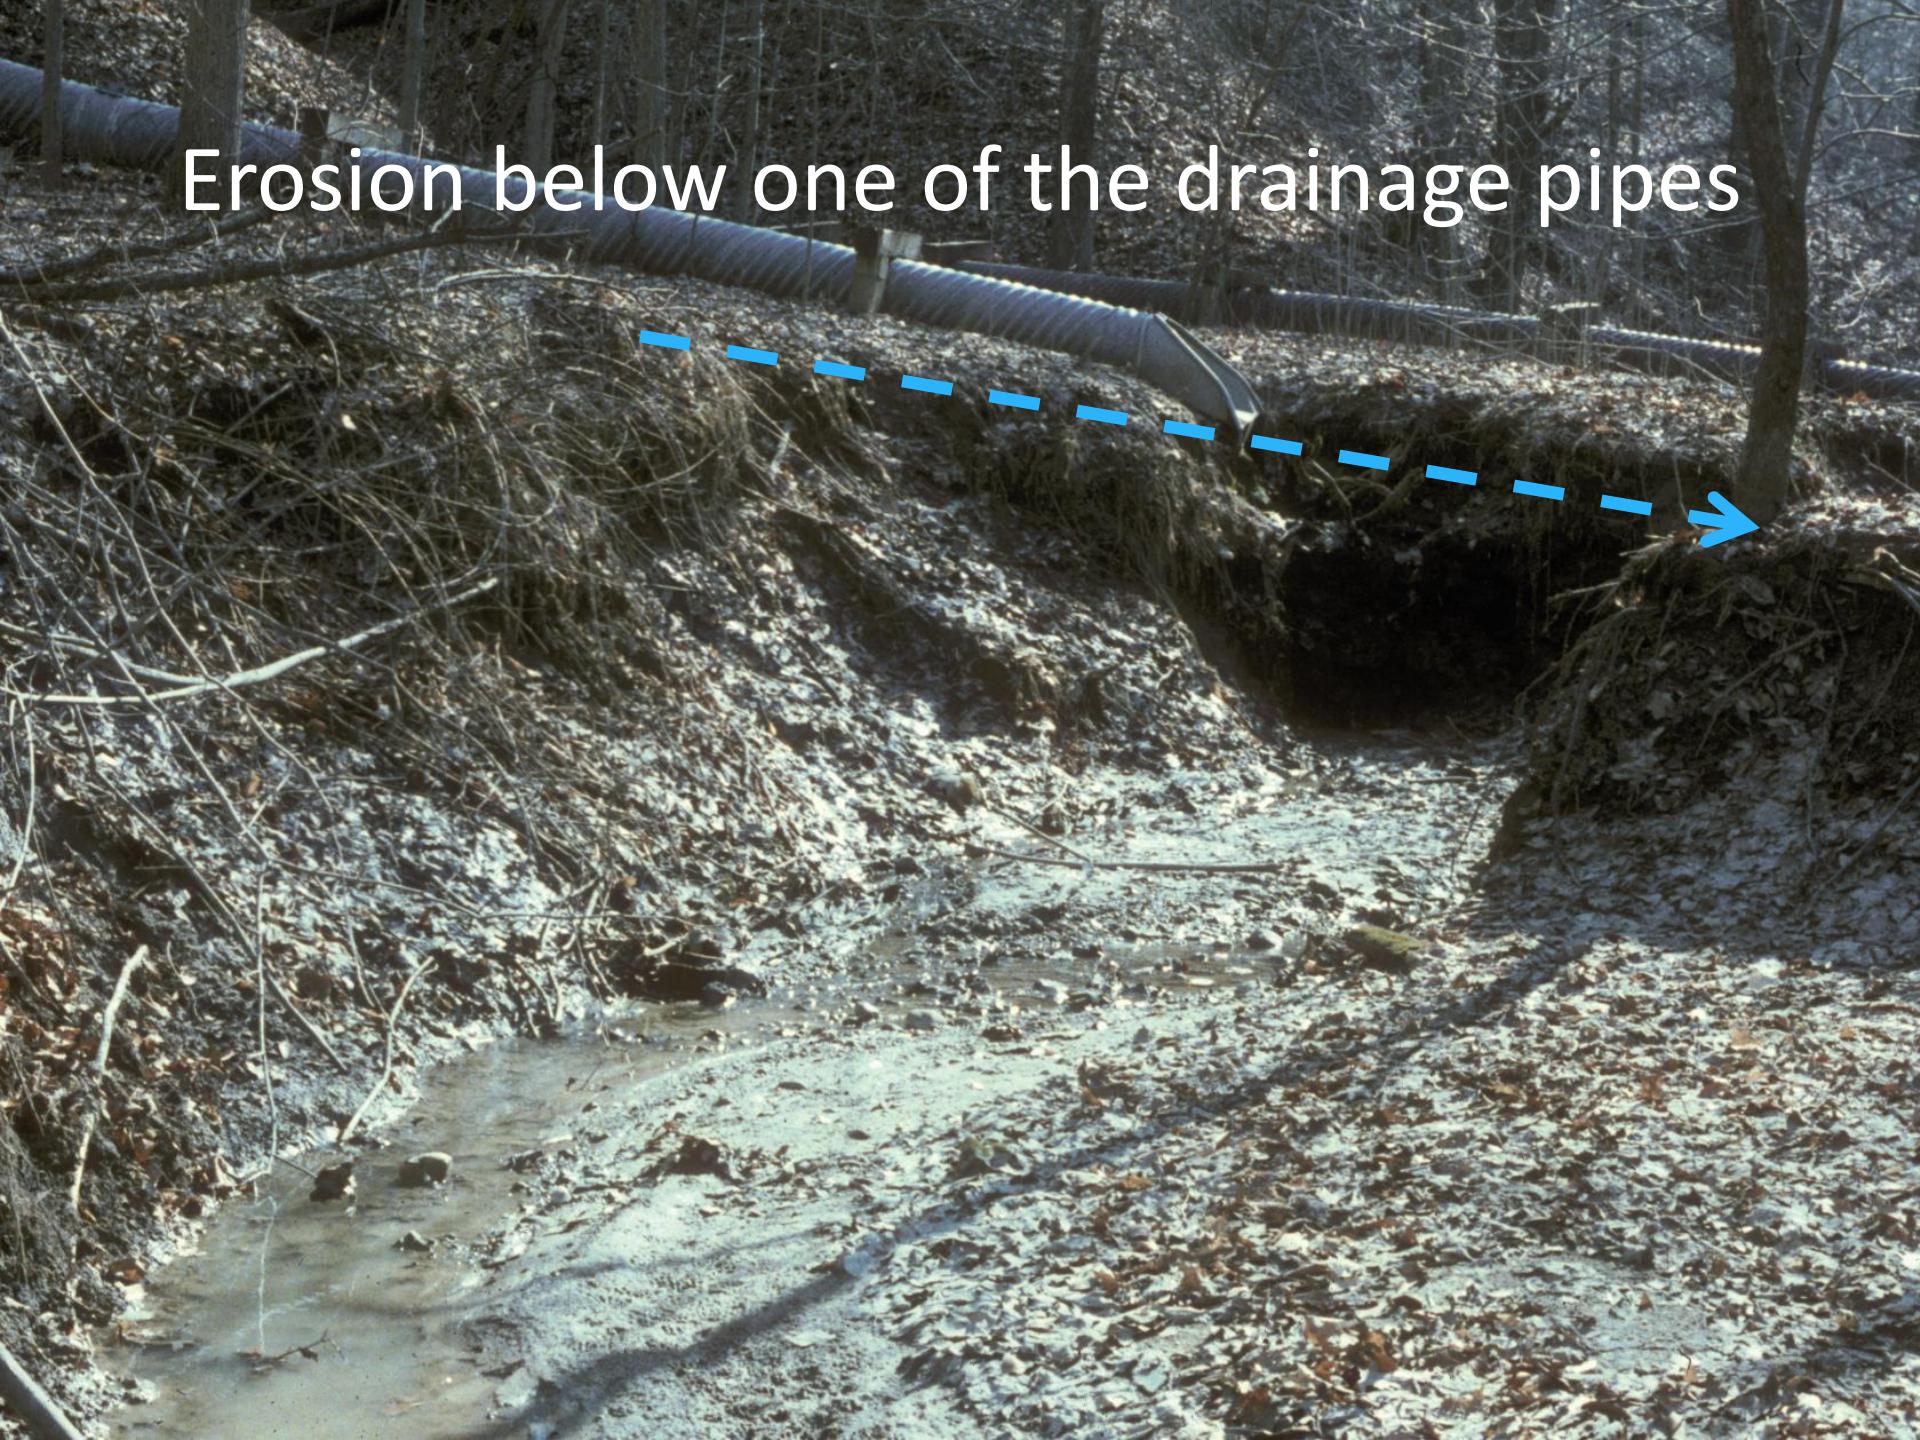
Erosion below one of the drainage pipes

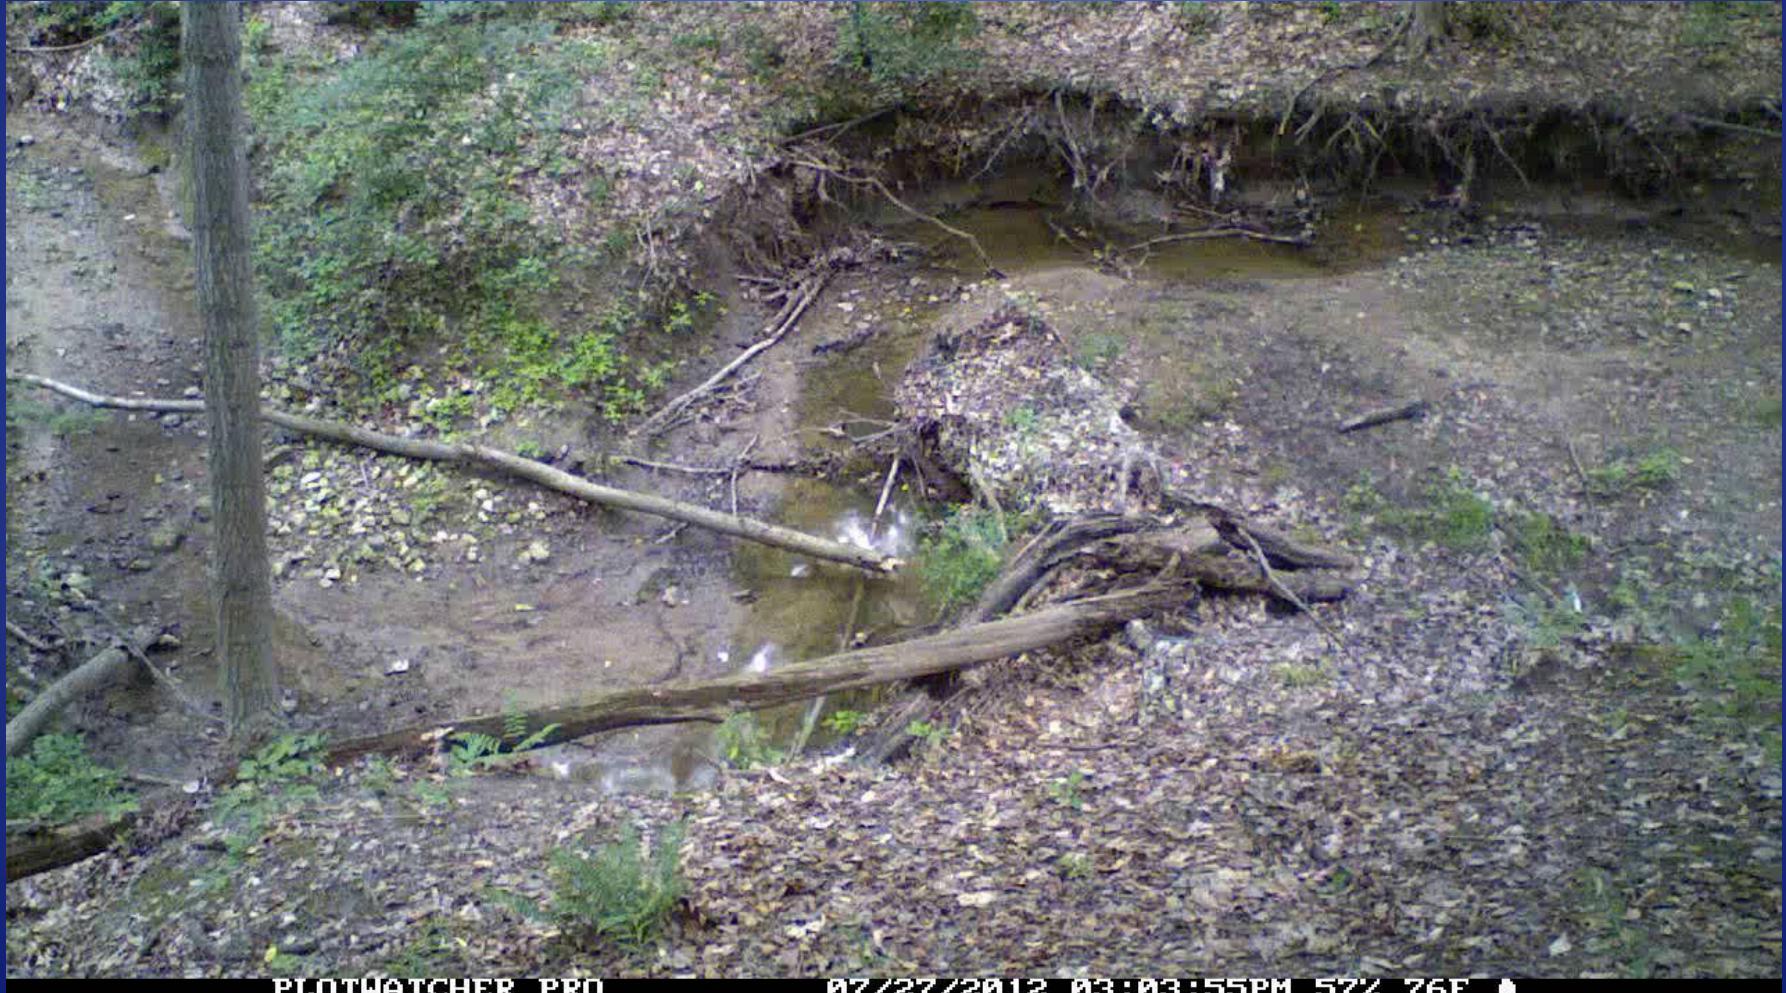
2012 flooding in the ravines after a
~ 1 inch rain in 30 min

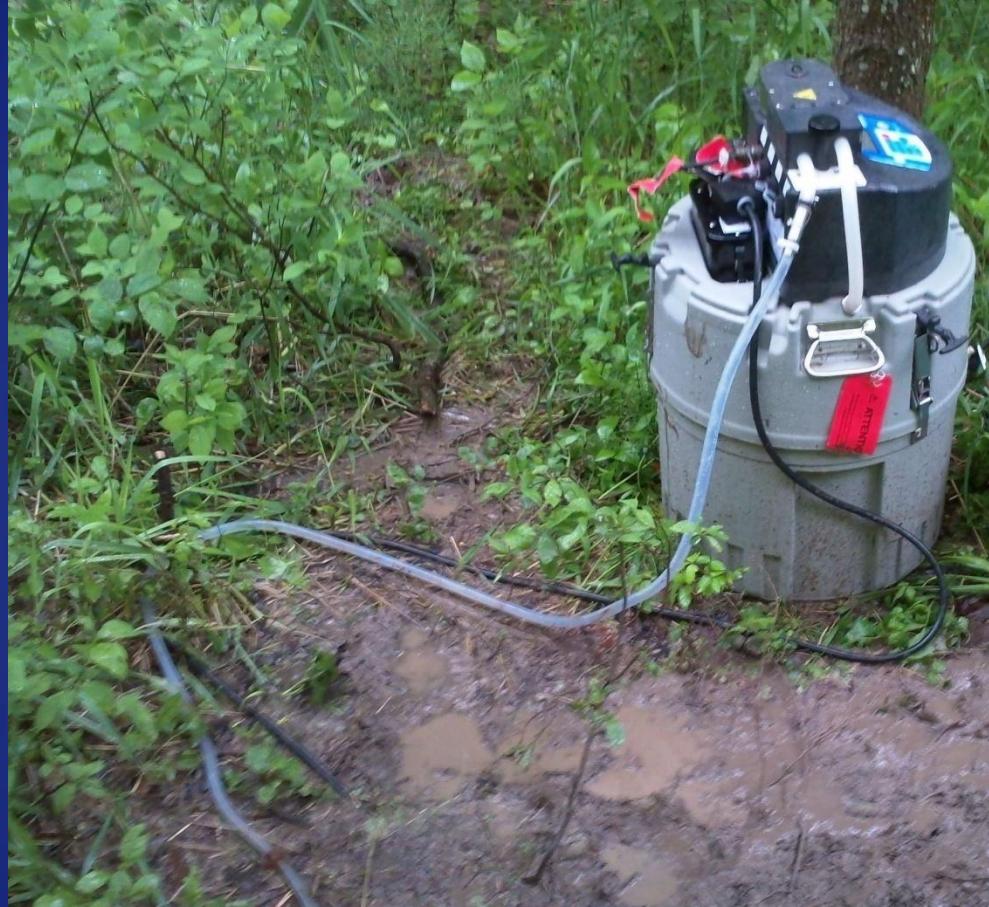
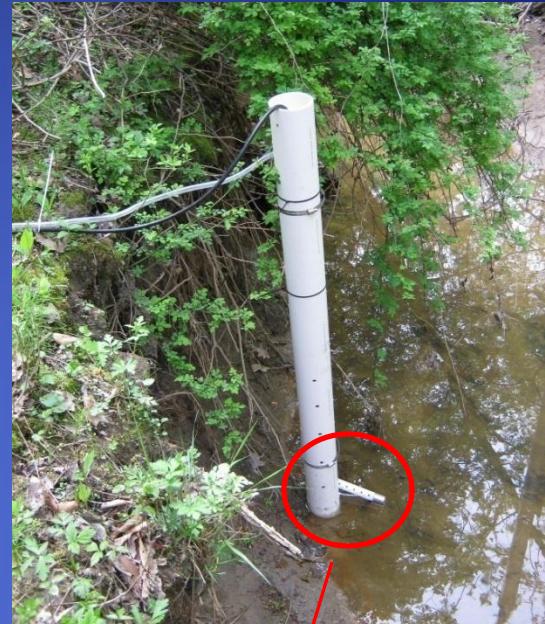
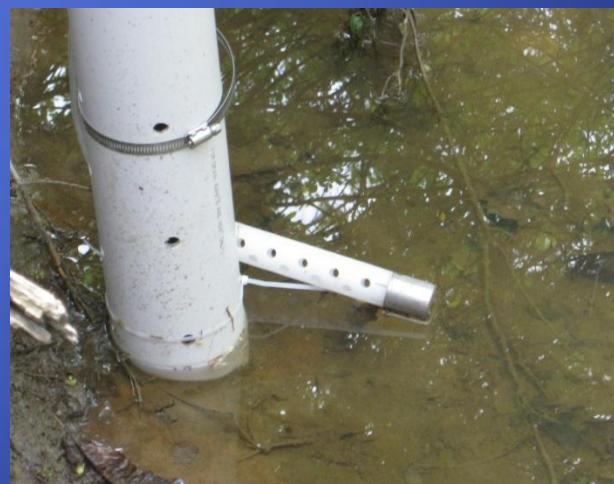
ISCO Sampler used for ravine Monitoring and sampling

Suction Head

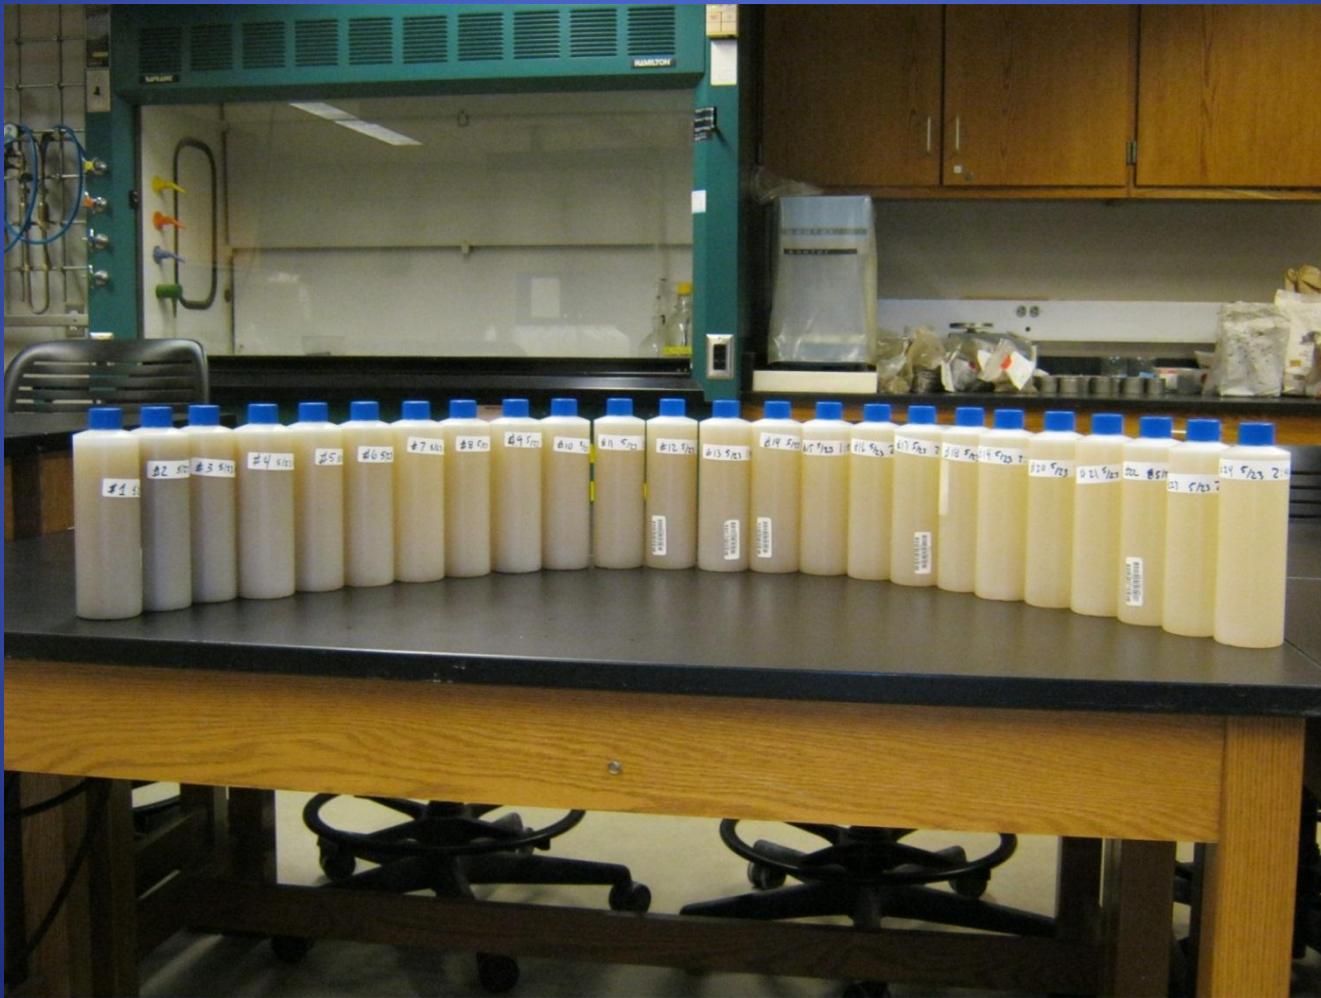
Sediment samples from 5/23/11

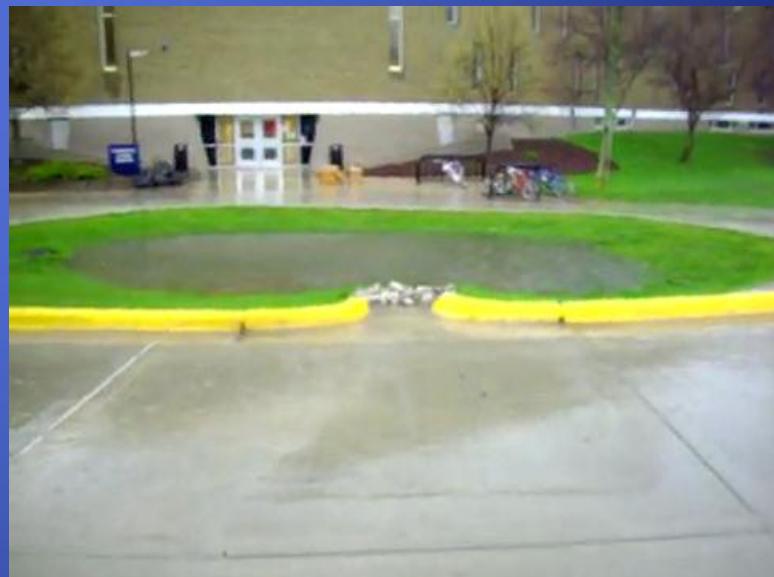
Mackinac Bio Swale after light rain

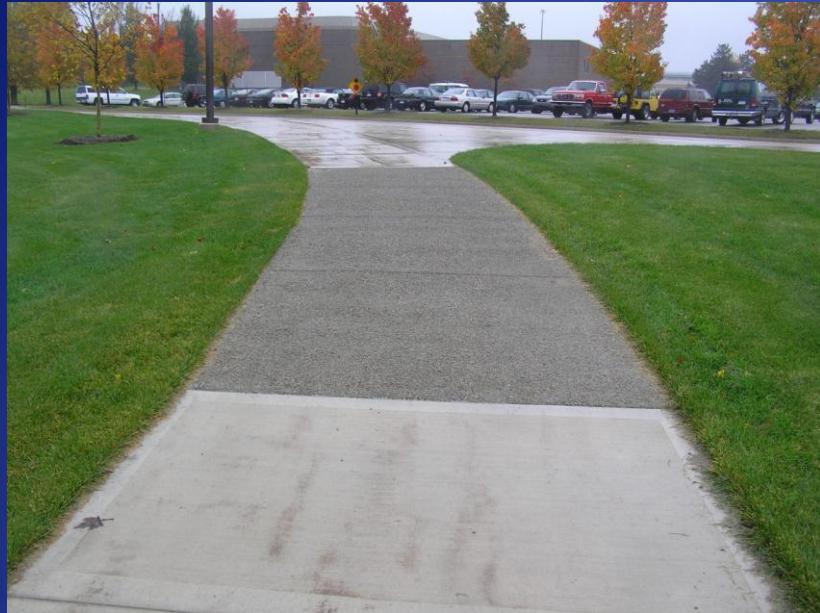
Mackinac Bio Swale after heavy rain

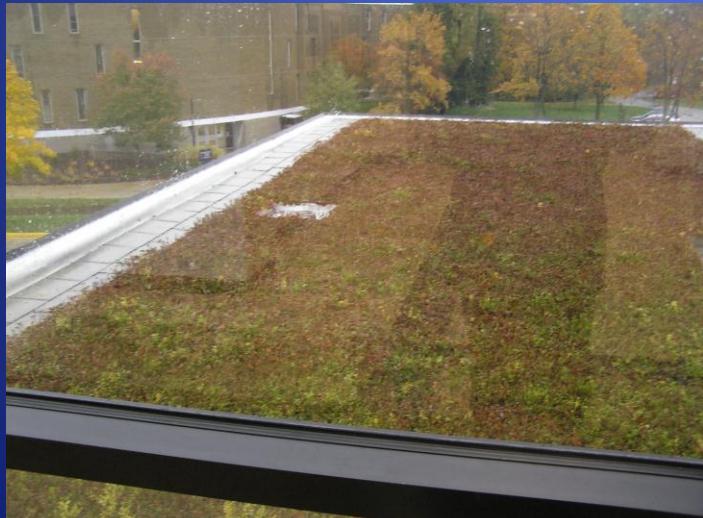
Permeable Concrete
Green Roof on Mackinac Hall

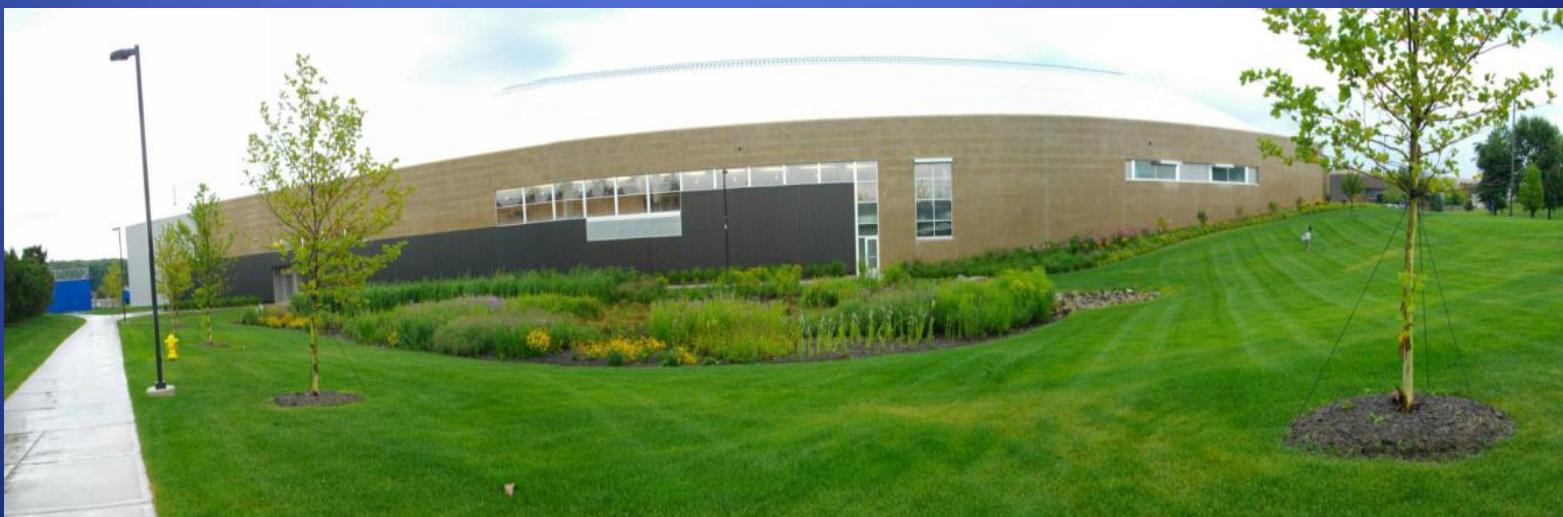
Turf Building Rain Garden
