# **Slag Filter BMP Preliminary Performance in the Macatawa Watershed, Monitoring Year 2**

**January 2022**

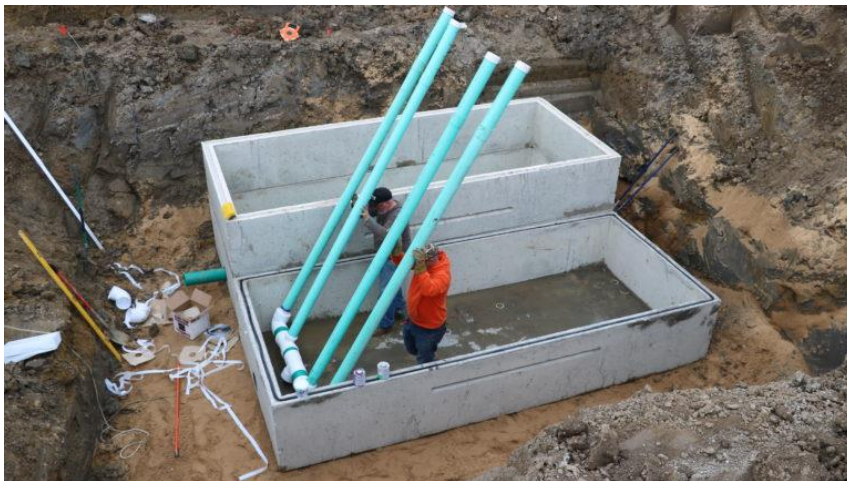
Figure 3. Inlet pipes being laid in the bottom of an iron slag filter. Drainage water enters at the bottom, moves up through the iron slag material (not yet installed) and leaves out a pipe near the top (not pictured) that leads to a nearby surface drain (not pictured). Photo credit: Macatawa Area Coordinating Council.

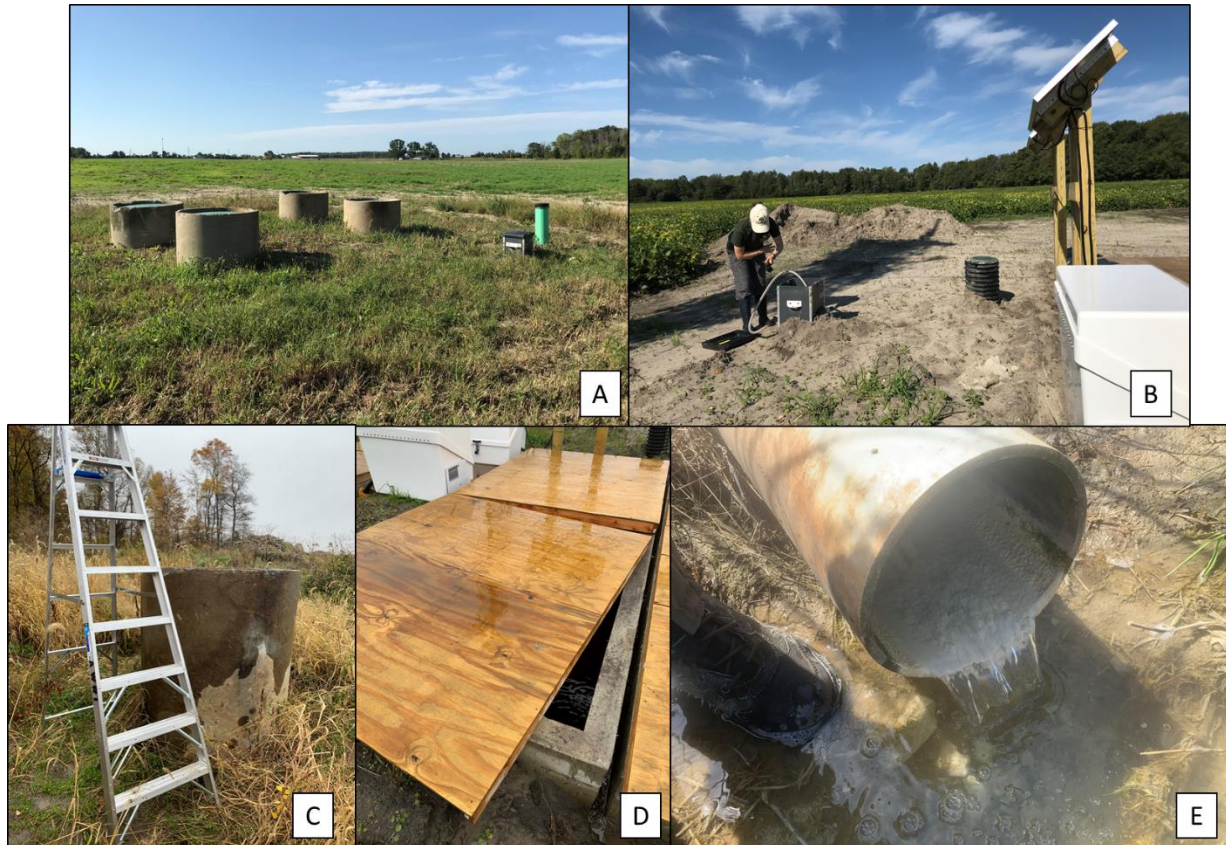
Figure 4. Photos of different sampling locations. A) Behind Mill 1 with completed iron slag filters in place. The green tube (far right) is an inflow sampling port that was installed only at this location. Access ports (for cement upright tubes) are for two slag filter basins (considered to be one slag filter site) that receive tile drain water from the adjoining field (in background) and are used to sample outflow. B) Sampling via a hand pump siphon to sample from a below-ground control box (inflow) at Fillmore Flex; Oak Grove 2 has a similar constructed inflow access (not shown). C) Slag filter outflow access point for Oak Grove 2, which required a ladder to remove the large plastic cap to sample outflow water. D) Slag filter outflow access point at Fillmore Flex, which is covered with large plywood lids. E) Outflow pipe at Behind Mill 1 directly after installation; the white particulate residue inside the tube is from the calcium carbonate layer placed on top of the iron slag inside the tanks to balance pH. Photo credit: Maggie Oudsema.

Prior to installation, grab samples were taken monthly at the outflow pipe, which at that time was a direct open connection from the tile drain pipes to adjacent surface waters. Pre-installation sampling dates are provided in Table 1. Post-installation samples were collected bimonthly; sampling approaches varied among sites due to differences in filter design and implementation (Figure 4). Post-installation sampling occurred at the inflow using a hand pump and hose to siphon water accessed through an inflow pipe at Behind Mill 1 (Figure 4A) and through a control box at Oak Grove 2, Fillmore Flex, and Joe's House (Figures 1, 4B). Outflow was sampled at the original outflow pipe (Figure 4E; which remained after installation) for all sites; however, when the outflow pipe was inaccessible due to being underwater (the surface drains are very flashy and water levels can rise quickly after a rain event [Steinman et al., 2018], submerging the outflow pipes), samples were taken via one of the access points on top of the tank using a hand pump and hose without disturbing the calcium carbonate top layer (Figures 4C, D).
