# GVSU Storm Water Monitoring Data Summary, Progress Report, and Recommendations

Dr. Peter J. Wampler  
Grand Valley State University  
Geology Department

*Final report submitted to GVSU Facilities Management August 2009*

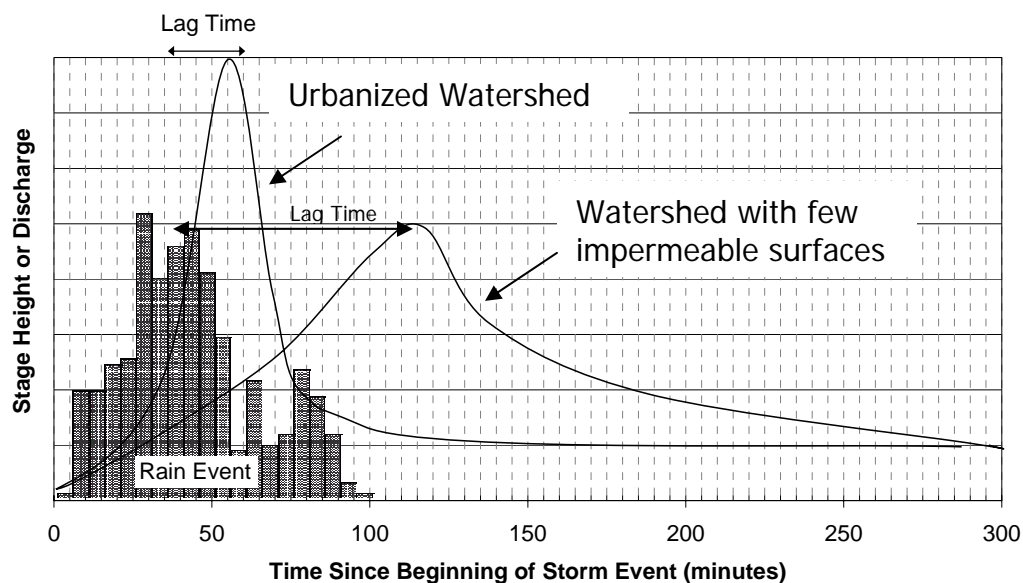
**Figure 1.** Example hydrograph showing lag time and the affect of urbanization on a typical runoff hydrograph.

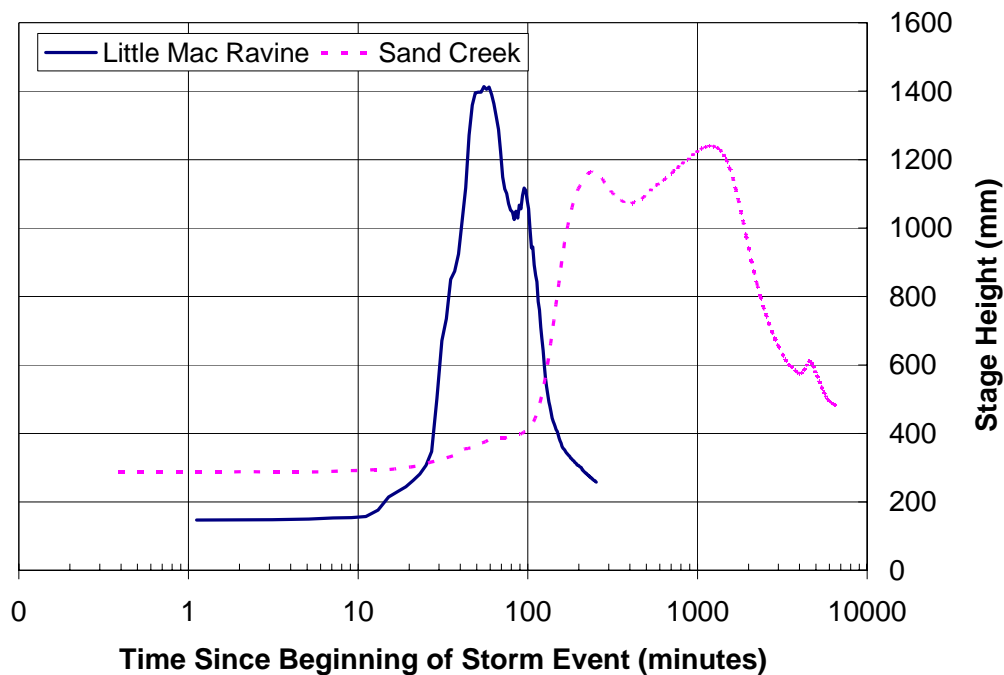
Lag times in the ravines near GVSU into which storm water runoff pipes are directed range from a few minutes to several 10's of minutes. Lag times for Sand Creek, a non-urbanized stream located northwest of GVSU, typically range from 100's to 1,000's of minutes. An example of the difference in hydrographs can be seen in the response to an intense rainfall (~2.25 inches in about an hour) event that occurred on July 17, 2006 (Figure 2). The lag time for lower Little Mac ravine was approximately 50 minutes, while Sand Creek experienced a lag time between 250 and 1,400 minutes.

**Figure 2.** Hydrographs for stream gages located at Sand Creek and Little Mac ravine during a rain event that occurred July 17, 2006.

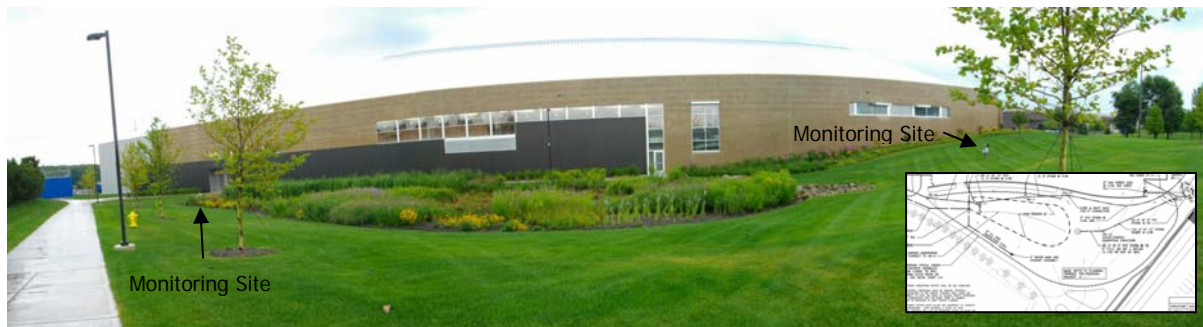
**Figure 3.** Photo taken August, 2009 of the Rain Garden and monitoring sites located near the Turf Building. Inset is the construction plan for the Rain Garden.

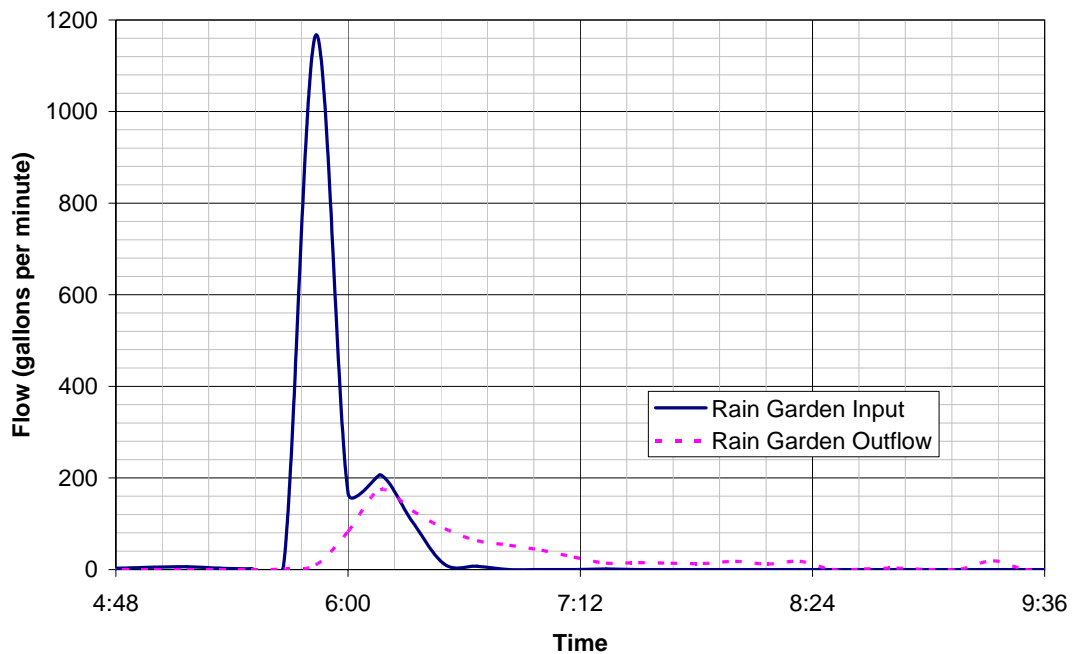
#### Turf Building Rain Garden - 7/11/09 Rain Event

**Figure 4.** Example of reduction flow as a result of the installation a large rain garden near the Turf Building, GVSU.

5. The Turf Building rain garden has demonstrated that rain gardens are an effective and aesthetically pleasing way to reduce storm water volume and increase lag time. Additional rain garden features are needed throughout campus.

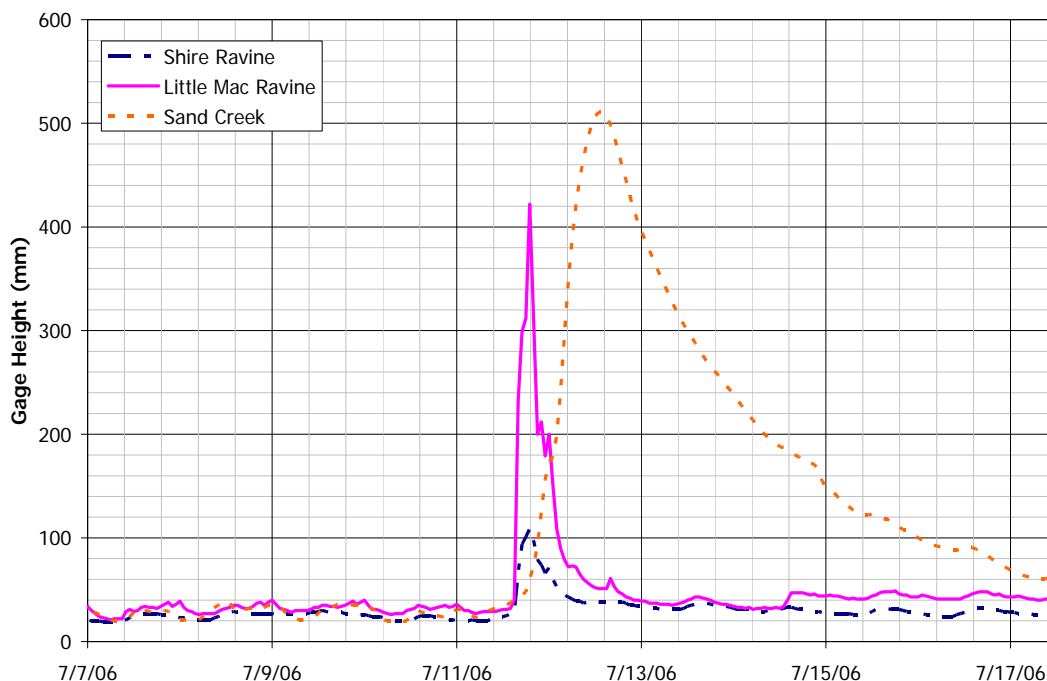
#### Hydrograph Comparison

The response to storm events is clearly different for ravines and watersheds receiving abundant storm water runoff from impermeable surfaces. The Shire ravine was used as a "control ravine". The watershed for the Shire ravine is largely un-impacted by campus runoff and has a hydrograph more similar to an un-urbanized stream like Sand Creek (Figure 6).

**Figure 6.** Comparison of Little Mac Ravine, Shire Ravine, and Sand Creek in response to a rain event that occurred 7/11/06.

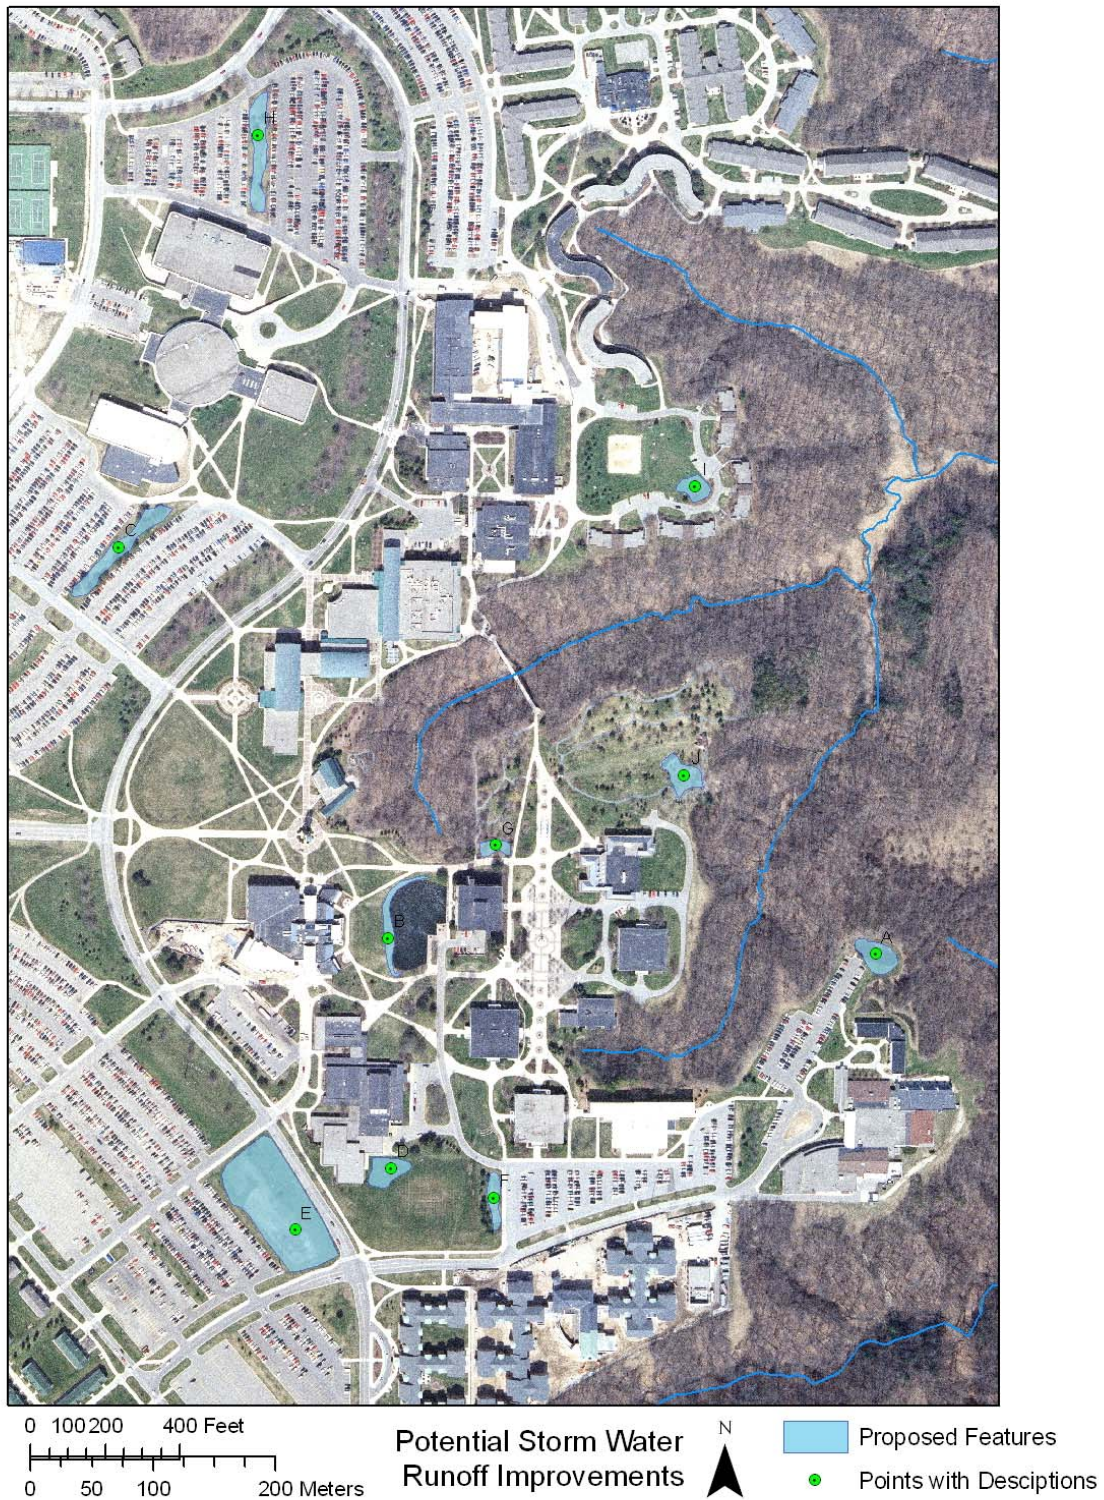
4/18/08 Aerial Photo

**Figure 8.** Potential storm water ponds and rain gardens.

6. There is a tendency to view storm water structures as merely functional. If carefully and thoughtfully designed, there is abundant opportunity on the GVSU Allendale Campus to add additional water features which both beautify the campus and solve runoff problems. Many opportunities for small detention pond structures, rain gardens, bioswales, permeable asphalt, and permeable concrete are needed throughout campus. Some of these opportunities are summarized in Figure 8 and Table 1.

Letter	Name	Description	Type	Category
A	Calder Pond Denention Pond	Needs 1) Move outlet); 2) more volume; 3) larger surface area; 4) complex shape.	Detention Pond	Retrofit
B	Zumberge Pond	Needs: 1) increase surface area; 2) allow natural vegetaion along edge; modify outlet	Detention Pond	Retrofit
C	Lot F Detention	Remove non-native pine trees and create a functional water feature	Detention Pond	New
D	Armstrong Pond	New Detention Structure	Detention Pond	New
E	Calder Campus NW	Modify existing detention pond	Detention Pond	Retrofit
F	Lake Michigan Hall Savannah	New Detention Structure	Detention Pond	New
G	Arboretum Pond	New Detention Structure	Detention Pond	New
H	Lot C Detention	New Detention Structure	Detention Pond	New
I	Volleyball Rain Garden	New Rain Garden	Rain Garden	New
J	Arboretum Detention Pond	New Detention Pond	Detention Pond	New
