Rush Creek Watershed

Ottawa and Kent Counties, MI

Field Surveys
performed by DEQ staff
October and November 2003

SUMMARY OF RUSH CREEK WATERSHED ASSESSMENT KENT AND OTTAWA COUNTY, MICHIGAN

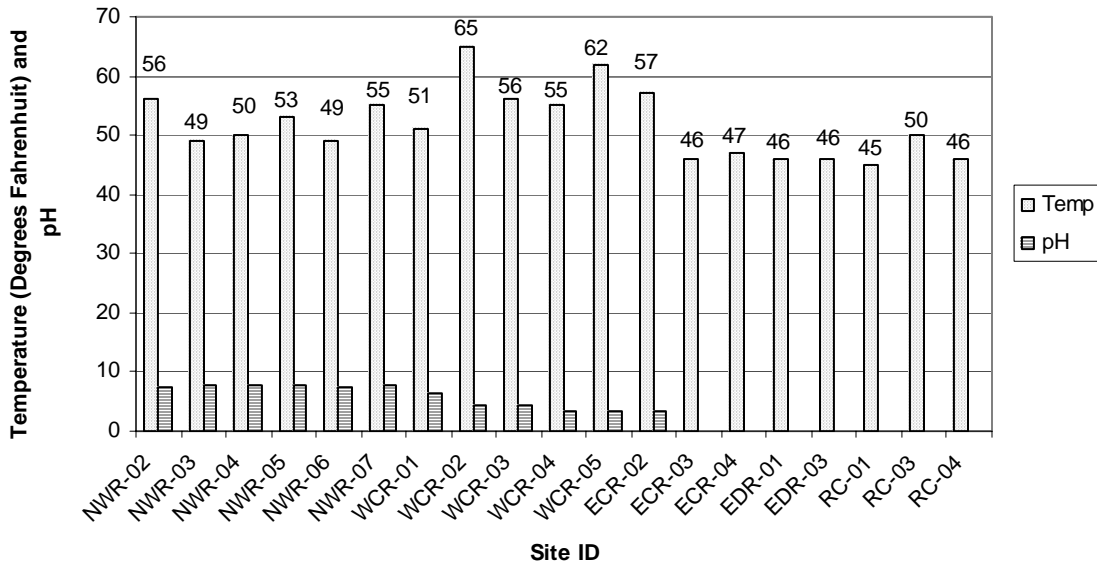
Figure 1. Temperature and pH summary for the Rush Creek Watershed
Note: Some stations lack pH data

conducted during the fall. Maximum air temperatures during the four field days of this survey ranged from 41°F (on November 7) to 68°F (on October 31). Refer to Figure 1 in Attachment B, which depicts the temperature and pH levels at all locations surveyed and to Figure 2, for only those temperatures and pH measurements for the mainstem locations.

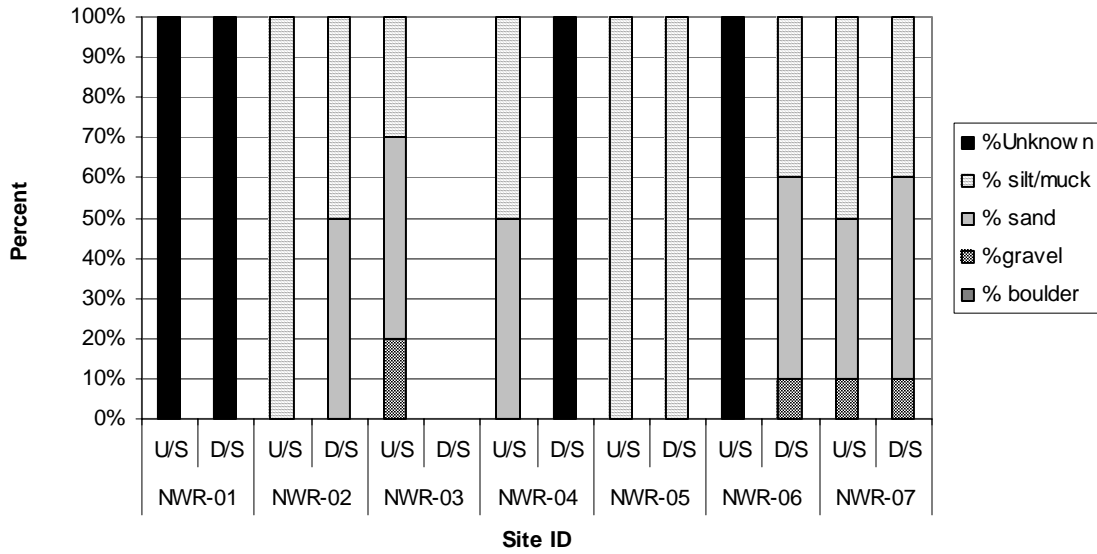
Figure 3. Percent substrate observations for each sample location in the Northwestern Rush Creek Subwatershed

Substrate was observed and quantified for both the upstream and downstream stretch at each survey location. In all, forty-eight substrate observations were recorded. Substrate type is important when considering habitat suitability for desired species within the system (i.e. trout and other fish species). Cobble and gravel substrates with a low degree of embeddedness are the most suitable for reproduction in many fish species and is important for macroinvertebrates as well. Evidence of silt and sand dominated substrate could indicate problems within the watershed such as erosion and sedimentation. Among the survey locations within the Rush Creek Watershed approximately 10% were dominated (80 to 100% covered) by sand and 17% were dominated silt, detritus or muck. 31% of the sites were unable to be categorized due to turbidity. None of the sites observed appeared to be dominated by cobble or gravel however 27% of the sites had some amount of gravel present (although it was always less than 50%). Refer to Figures 3 through 6 for substrate data for each of the subwatersheds separately. Refer to Figure 7, in Attachment B, for a graph depicting the substrate composition for those survey locations located along the main channel of Rush Creek.

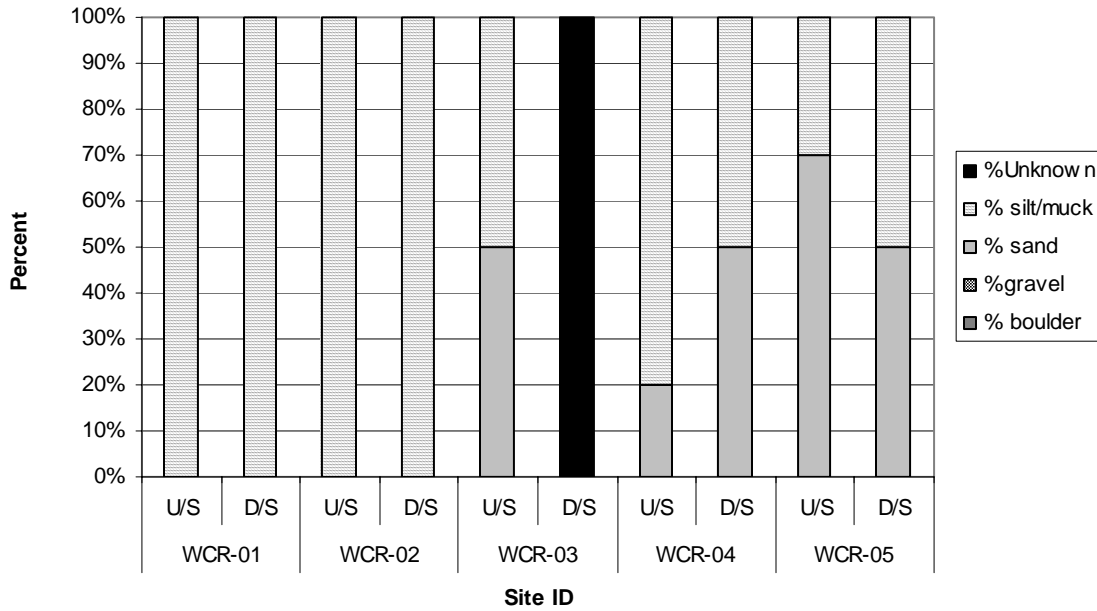
Figure 4. Percent substrate observations for each sample location in the Western Central Rush Creek Subwatershed

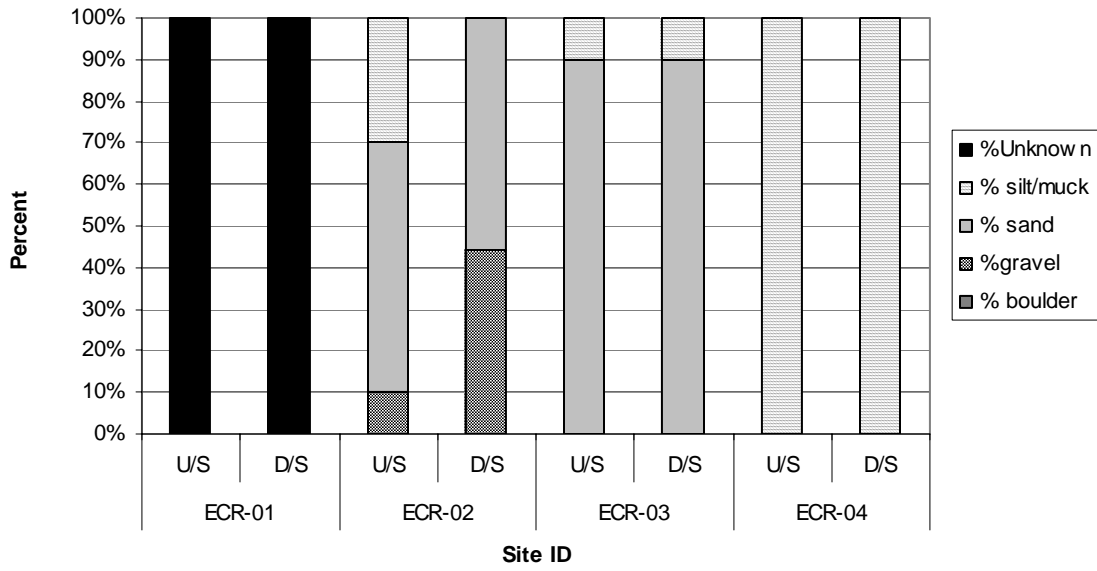
Figure 5. Percent substrate observations for each sample location in the eastern Central Rush Creek Subwatershed

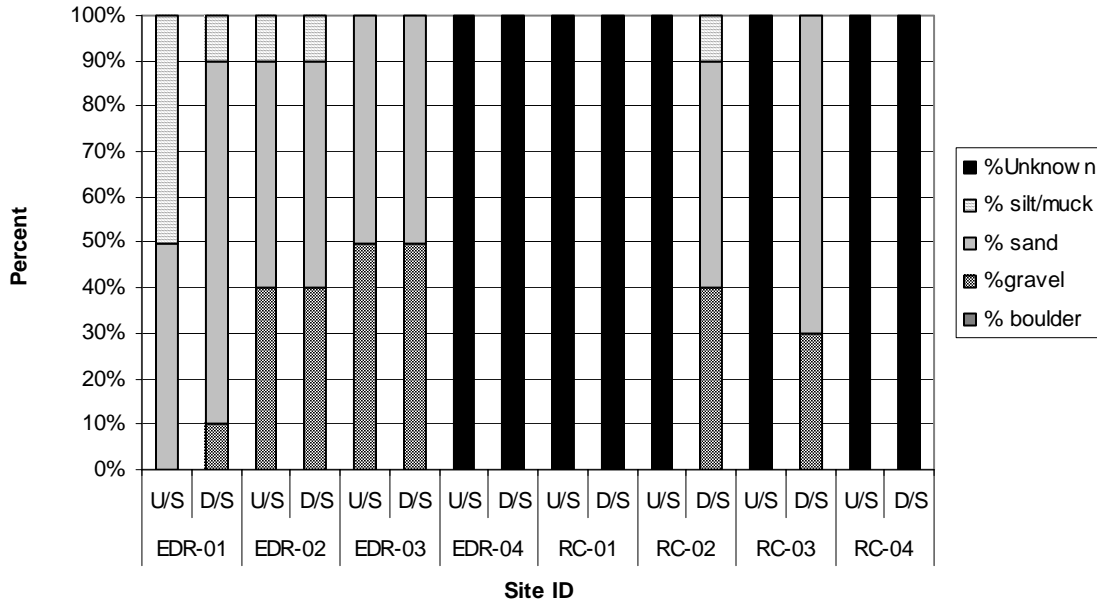
Figure 6. Percent substrate observation for each sample location in the Eastern Drain to Rush Creek (EDR) and the Rush Creek Subwatersheds

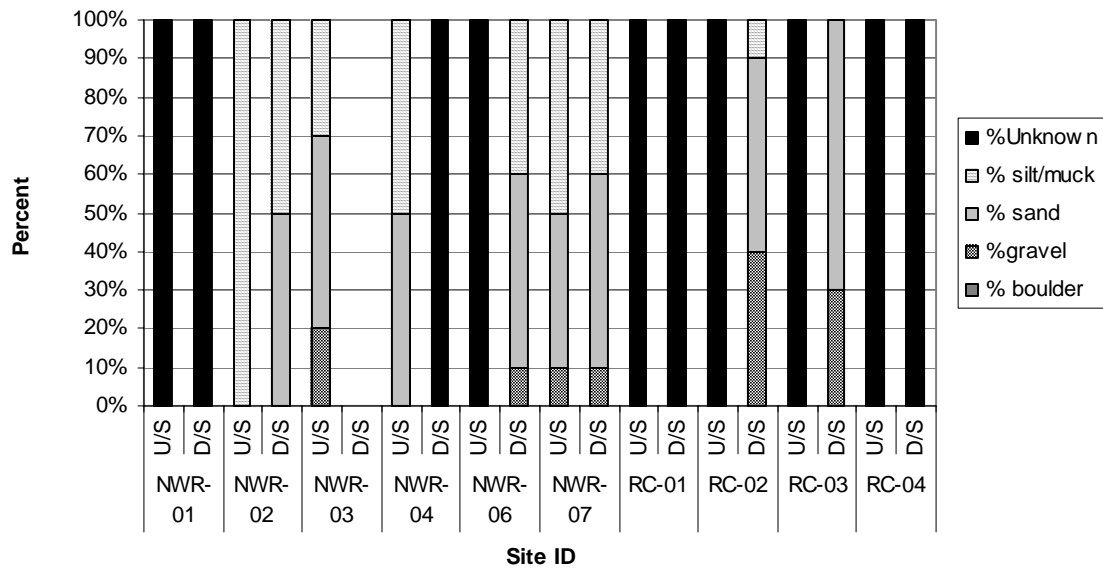
Figure 7. Percent substrate observation for the mainstem sample locations from the headwaters th the mouth of Rush Creek

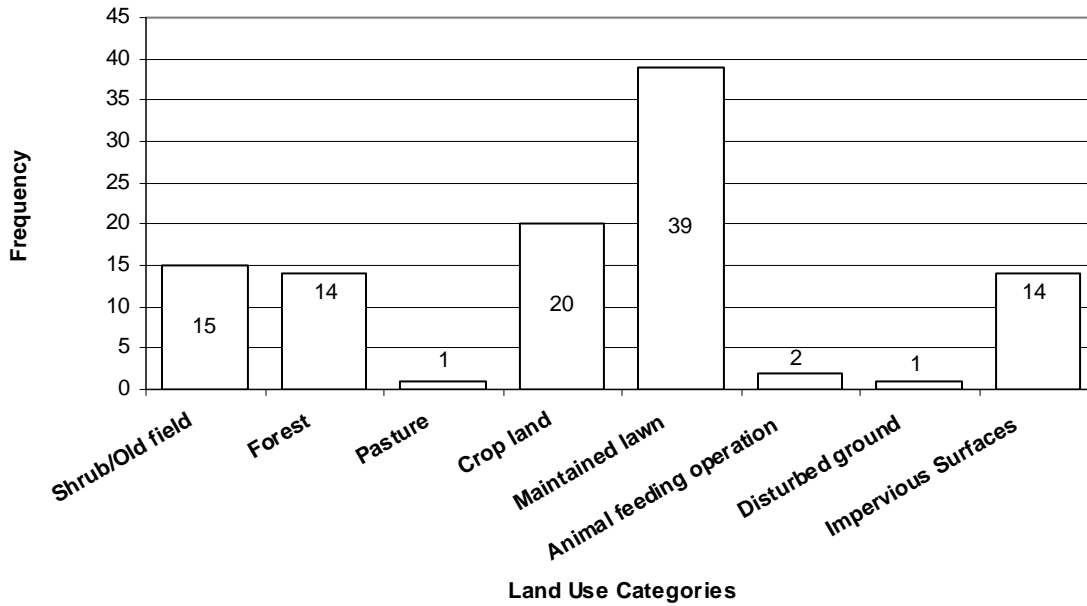
Figure 8. Summary of adjacent land uses

Adjacent land uses were recorded at each survey location for both the upstream and downstream stretches as well as both the right and left banks. Because the entire section of stream that can be seen from the road crossing is evaluated, multiple land uses can be recorded for each site. Land uses within the watershed play an important role in nutrient input, erosion, and in-stream conditions that affect water quality, quantity and habitat. Refer to Attachment B, Table 4 and Figure 8 for a summary of all the adjacent land uses recorded within the watershed. The most common adjacent land uses were maintained lawns, cropland, forest, shrub/old field and impervious surfaces followed by a lesser number of observations for pasture, animal feeding operations and disturbed ground.

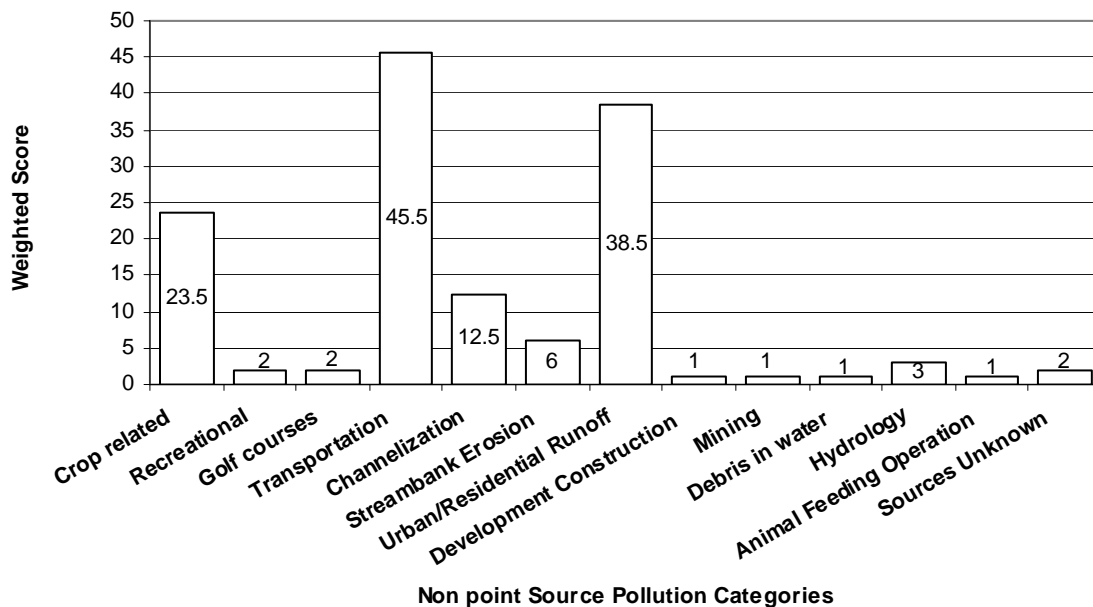
Figure 9. Weighted values for possible sources of non point source pollution (cumulative score for all locations)

During the completion of the road stream crossing surveys, field staff also evaluated the *potential* for non point source pollution. This assessment focuses on the severity of *potential* pollutant *inputs*, not pollutant *impacts*. As part of this evaluation process field staff look for 1.) a possible pollutant source, 2.) a potential pathway to the waterbody and 3.) potential severity of the input. Because each potential source was given a ranking of slight, moderate and high for severity, the values recorded were weighted before they were summed for each category (Refer to Figure 9, Attachment B). Observations recorded as slight were considered to be the basis for comparison, therefore observations recorded as moderate were multiplied by 1.5 and observations recorded as high were multiplied by 2. Potential non point source pollution from transportation, crop related sources and urban residential runoff were the most serious while streambank erosion, channelization and hydrology were also considered common sources of NPS pollution. Refer to Table 5 in Attachment B for a summary of the non point source pollution observations identified for each survey location.
